# Cervejas De Moçambique Structural Roof Assessment

Client: Cervejas De Moçambique

Reference: KA1831-RHD-ZZ-XX-RP-Z-0001

Date: 2/25/2021

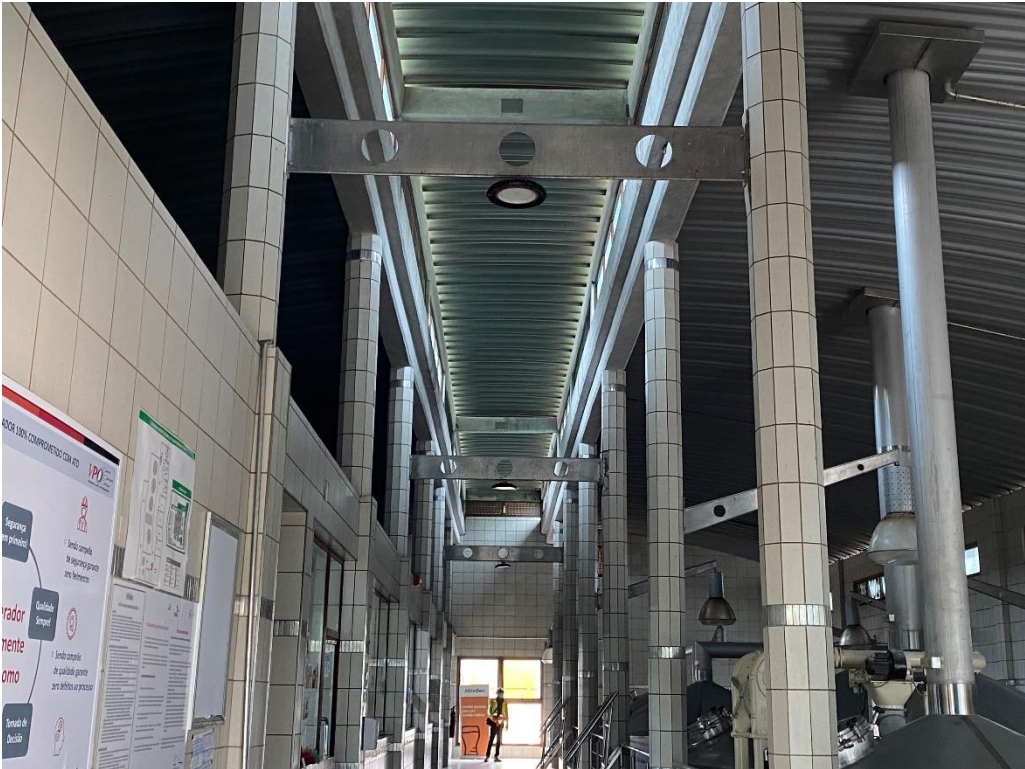
This building requires special attention to the structure below the roof itself which has significant damage to the columns and must be addressed as soon as possible. Some concrete columns may have rotated causing the concrete to loosen where it is fixed to a connection beam. Specialized tests must be done to determine the extent of the damage and the resistance to the elements.

7. Brew House: damaged concrete columns

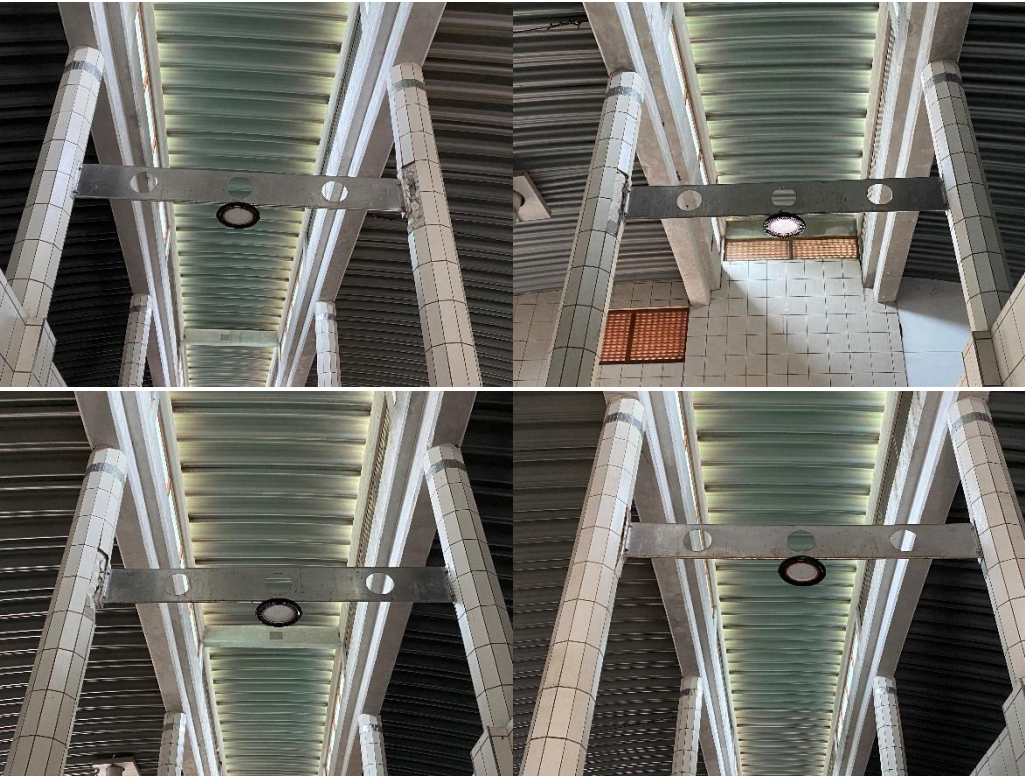
8. Brew House: closer look at damaged concrete columns showing detachment of concrete

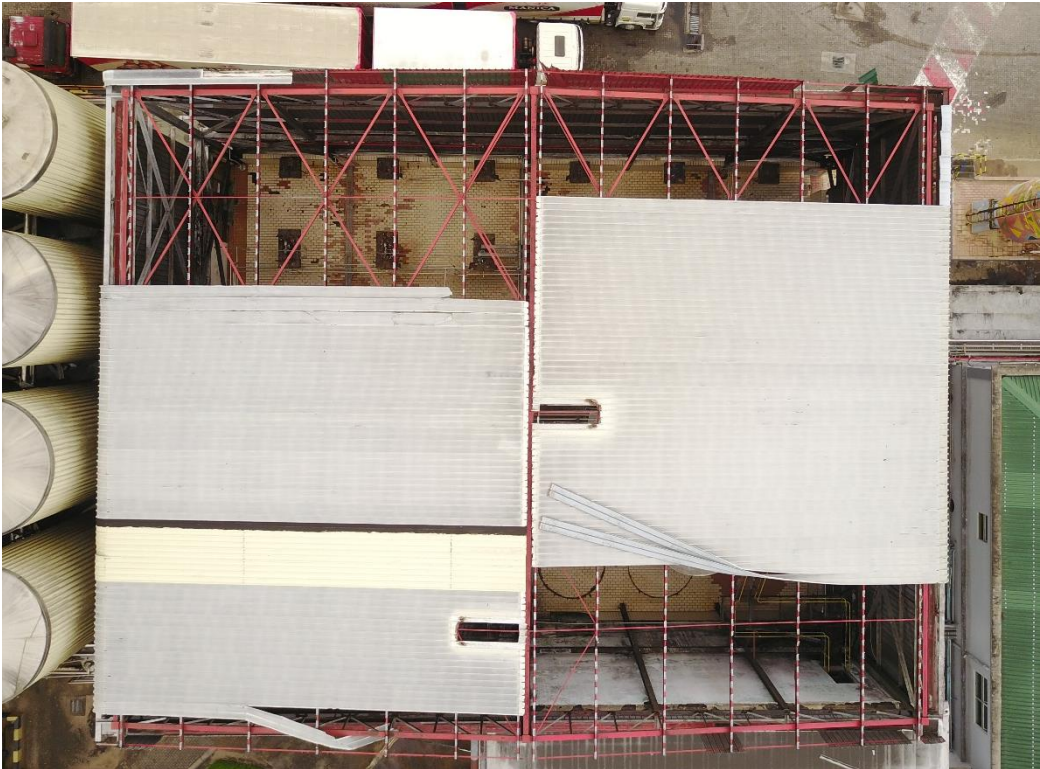
The Old Cellars is an old building (around 60 years old) and there seems to be no maintenance of its structure. It is one of the buildings that was most affected by the cyclones. Half of the roof sheeting is gone due to the strong winds leaving the roof structure exposed and the remaining roof sheeting is severely corroded.

9. Old Cellars: top view

The roof trusses can still be used but need proper treatment and maintenance. The purlins and roof sheeting must all be replaced. There is currently no rainwater collection system, such as, through roof gutters and a completely new system of roof stormwater collection must be installed.

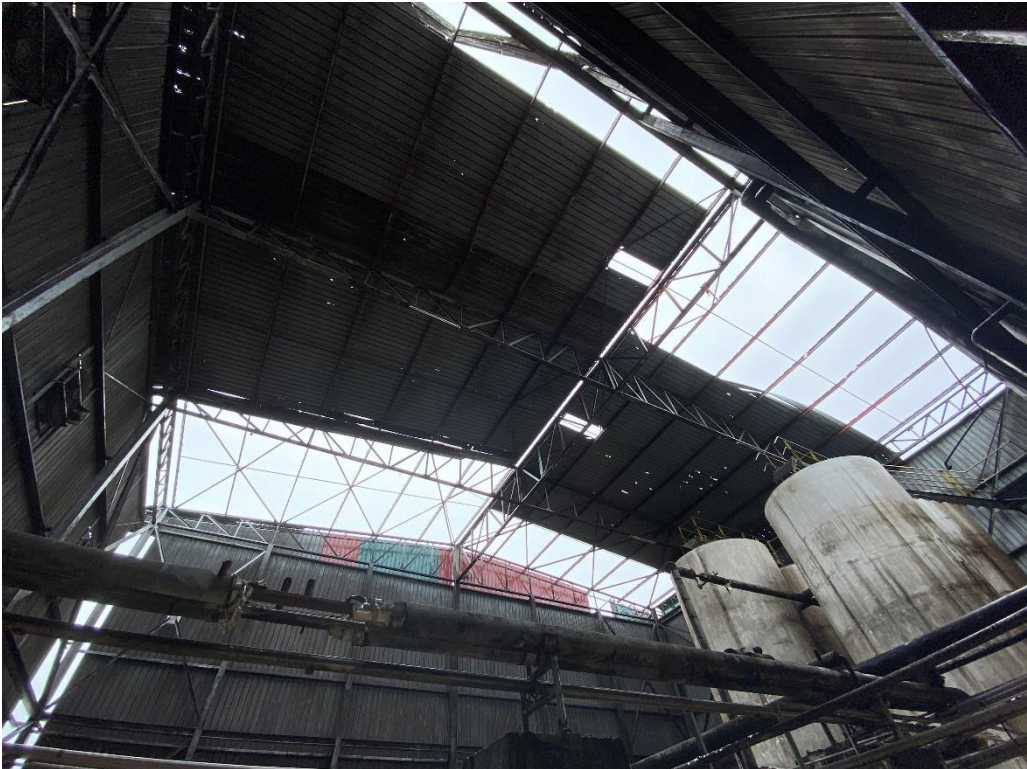
10. Old Cellars: roof view from inside the building

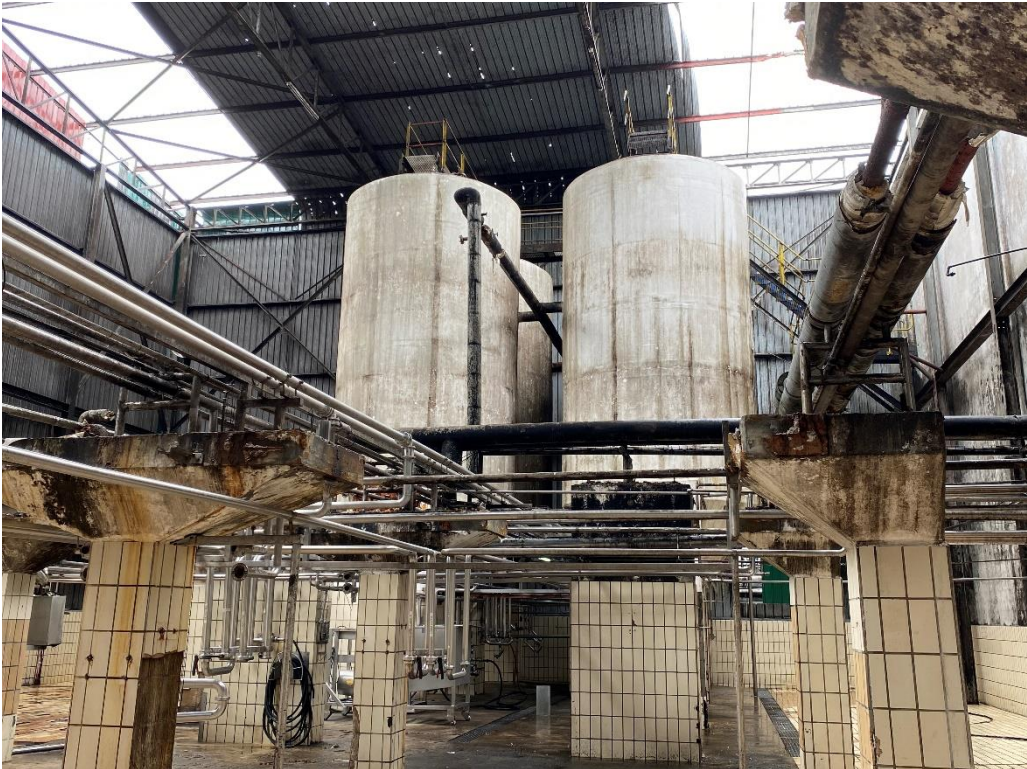
The rest of the building also requires intense repairs. Some elements of the steel structure show signs of corrosion but can be repaired and treated, where the connections appear to be intact. But some columns present an advanced state of corrosion and require replacement.

11. Old Cellars: view inside the building showing the damages in the supporting structures

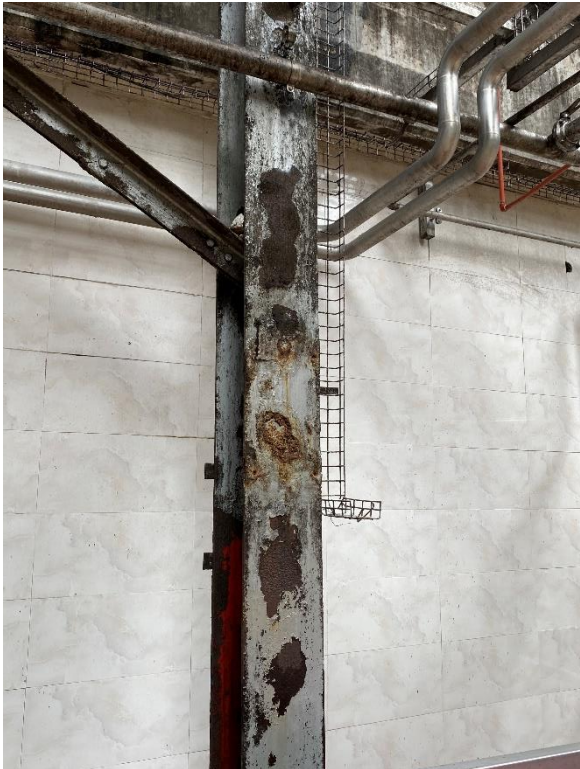
13. Old Cellars: structural column with advanced state of corrosion

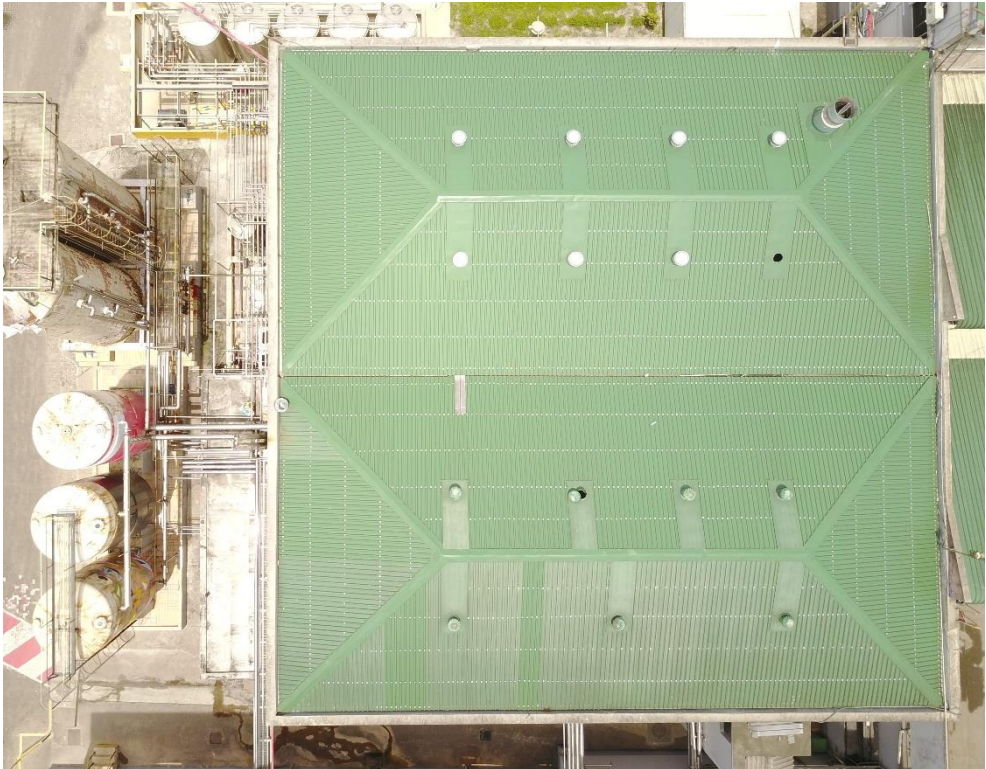
14. Canteen and Filtration: top view (misplaced whirlybirds)

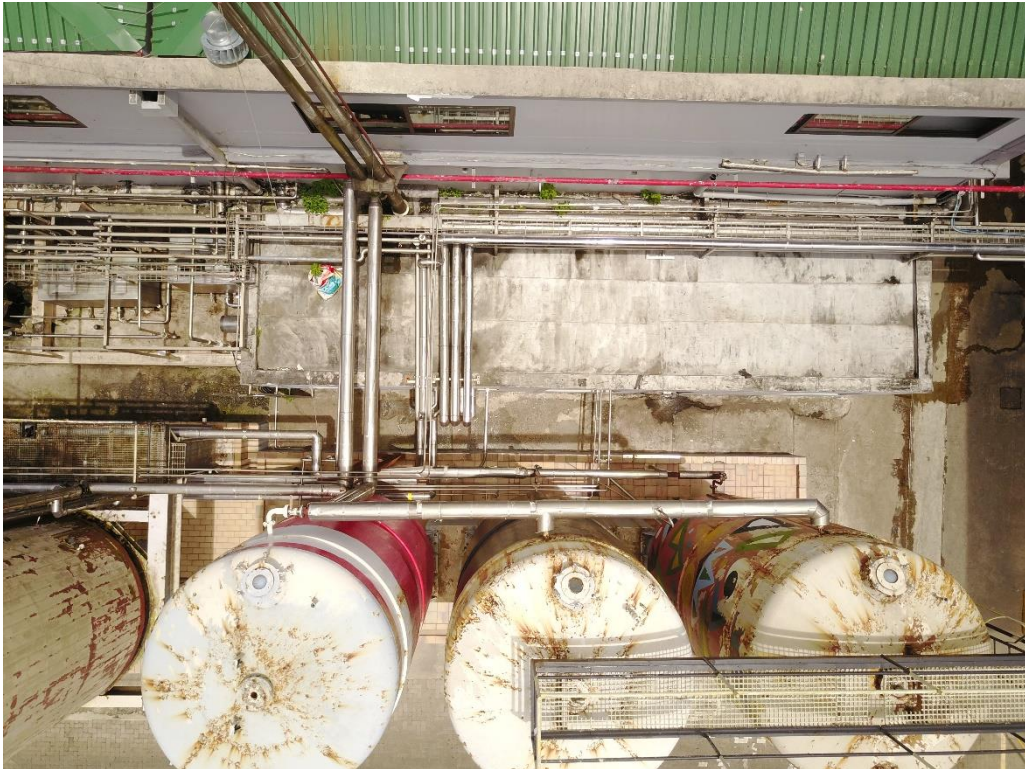
15. Canteen and Filtration: closer top view of filtration room (bushes growing on the roof)

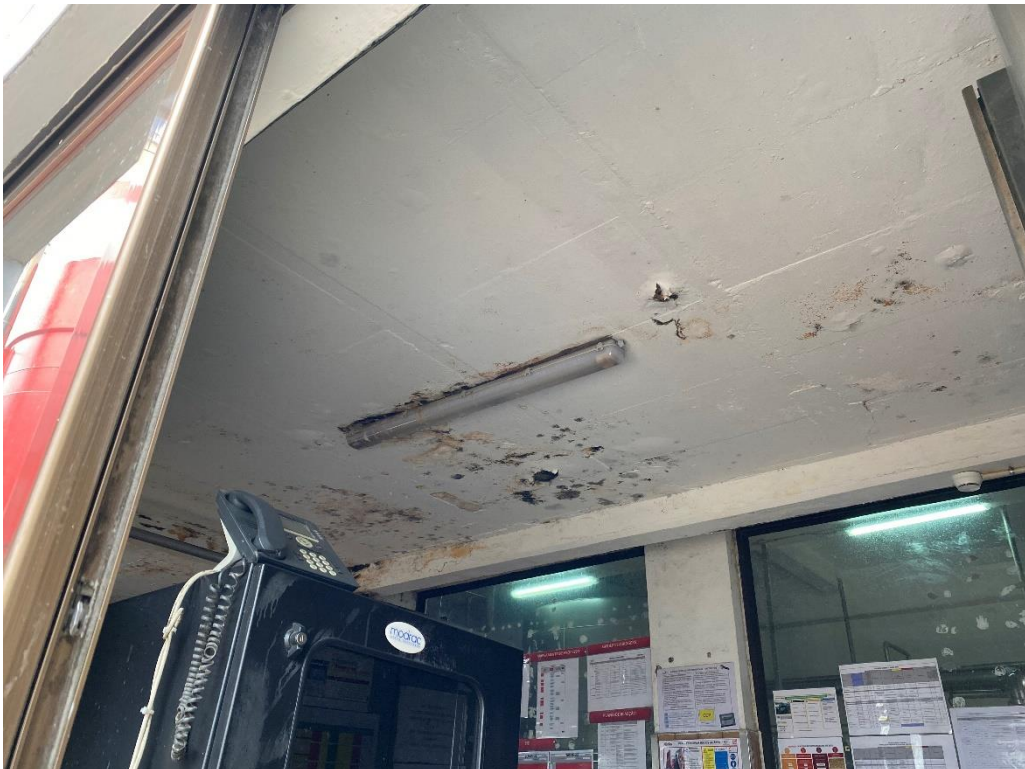
The waterproofing membrane on the slabs of the filtration room is worn and no longer have the required properties. There are signs of accumulated humidity, with air pockets and sections of the membrane that are loose and therefore the ceilings below display signs of accentuated stormwater infiltration. The waterproofing membranes must be substituted.

16. Canteen and Filtration: water infiltration on the slab soffit of filtration room

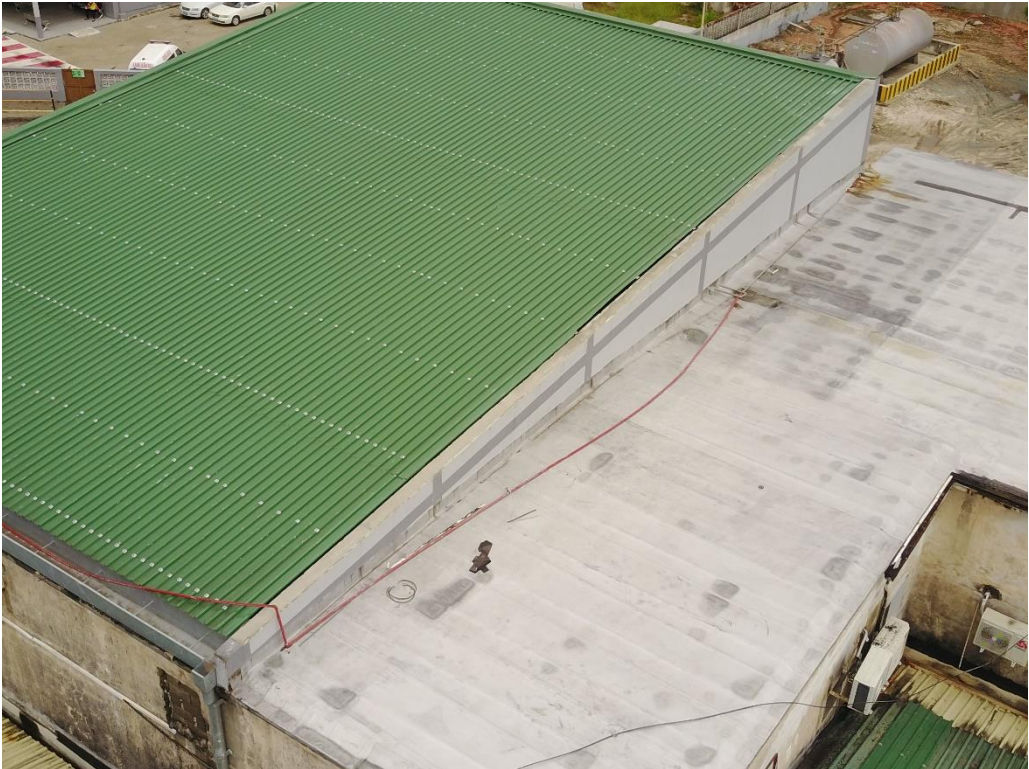
It was not possible to inspect the roof structure of the laboratory from the inside because of the ceiling but signs of stormwater infiltration was visible. With the images taken from the drone, it was possible to see that the lateral roof flashing is missing, and this causes the water ingress. This issue must be addressed by installing new roof flashing.

18. Laboratory and Technical Building: no flashing

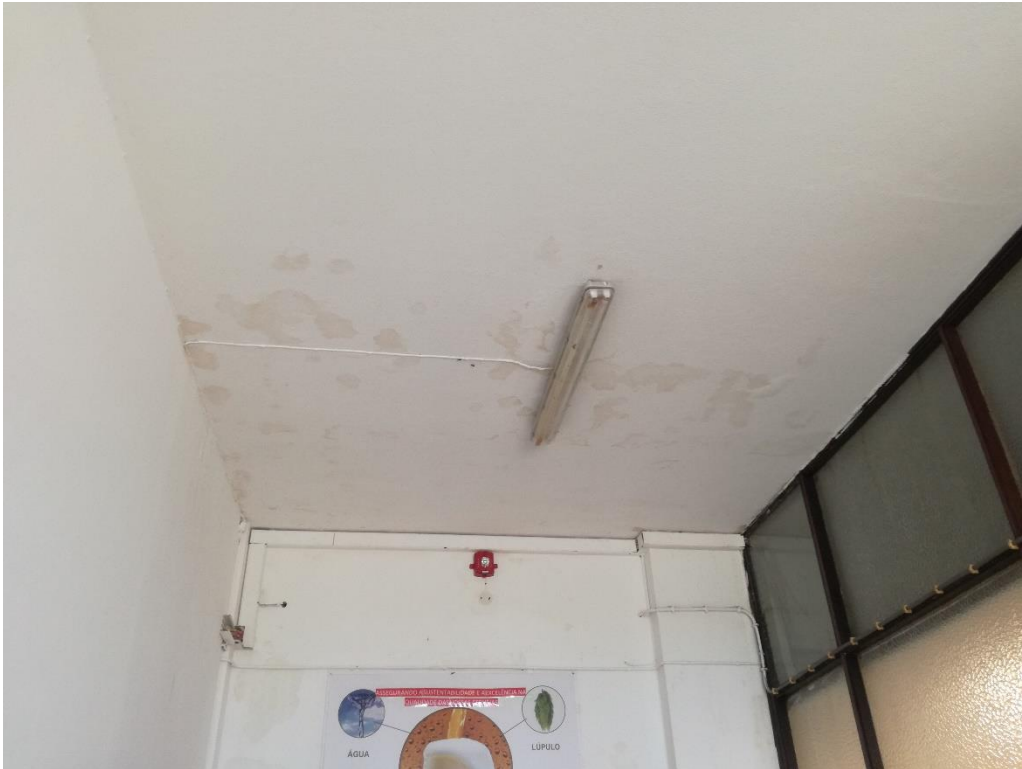
19. Laboratory and Technical Building: water infiltration in the slab soffit

The waterproofing membrane on the slab of the technical building must be repaired. It is not sealed properly between the lateral wall and the roof structure of the next building allowing water ingress and causing infiltration marks on the walls.

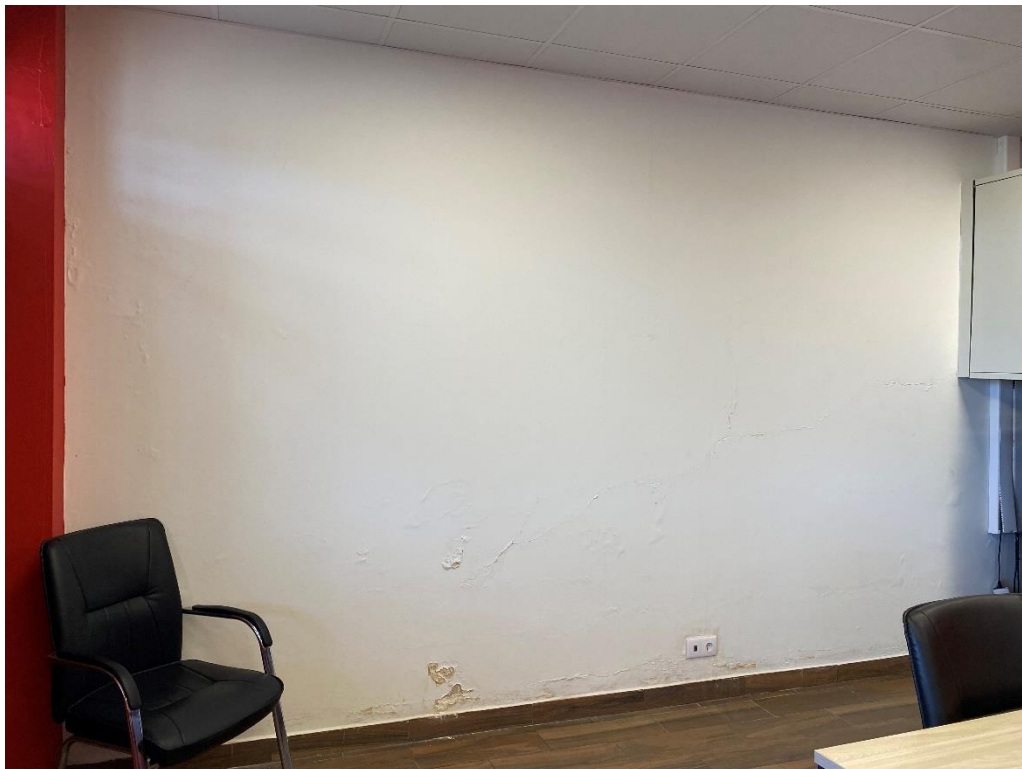
20. Laboratory and Technical Building: infiltration in the wall

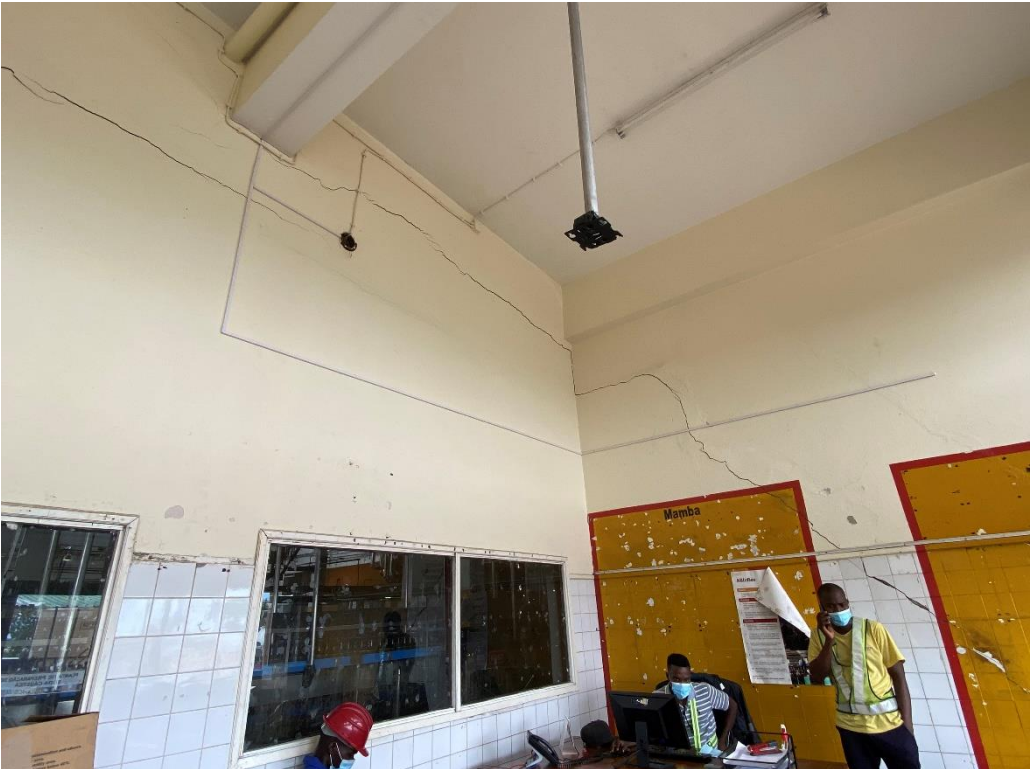
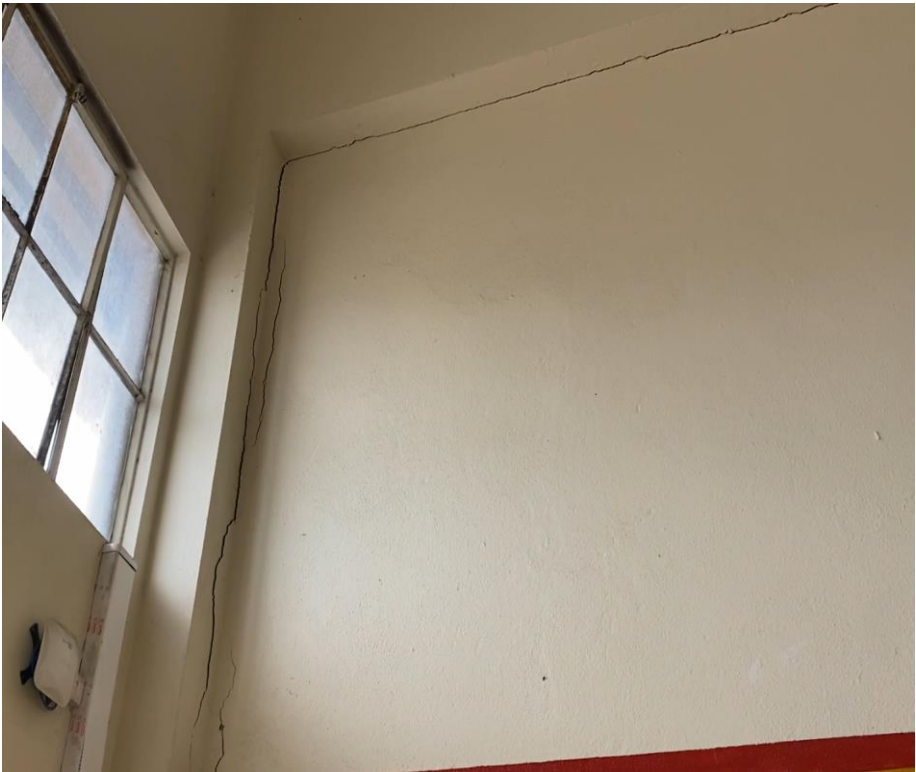
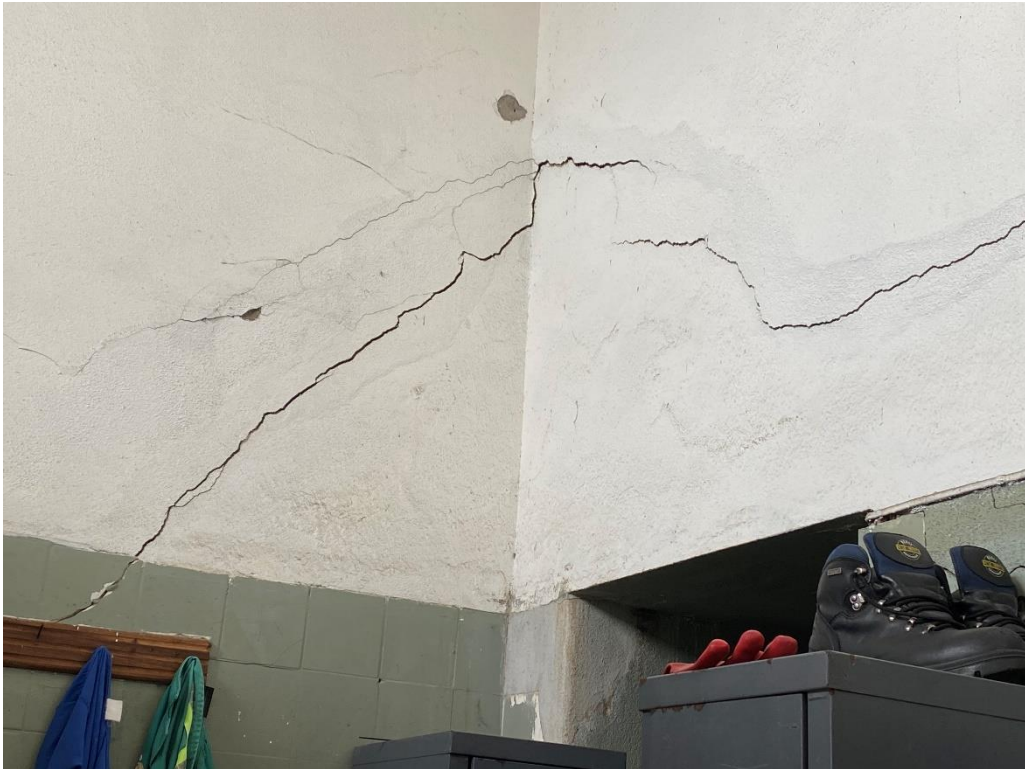
It is important to address a situation of settlement happening in the building. There are cracks on the floors and large cracks along the walls on the ground floor. Specialized tests must be done to determine the extent of the damage and whether these cracks are propagating. This should be done as soon as possible.

21. Laboratory and Technical Building: large cracks in the walls

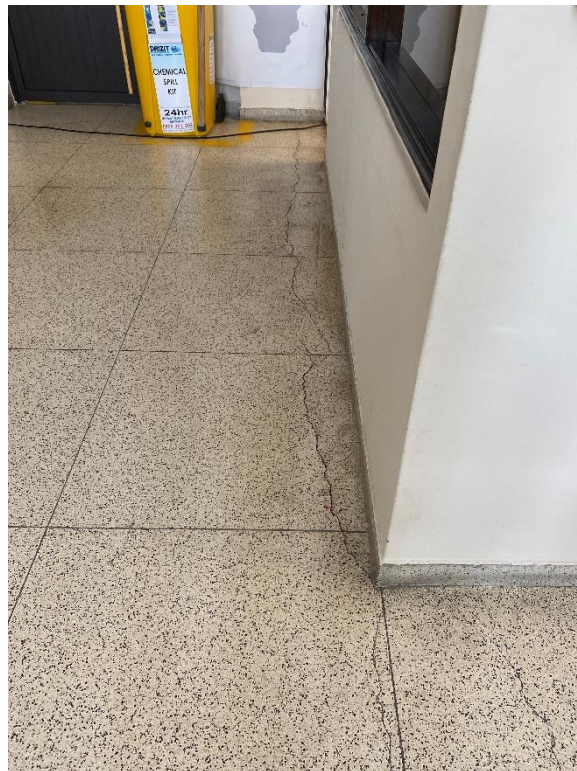
24. Laboratory and Technical Building: large cracks in the floor

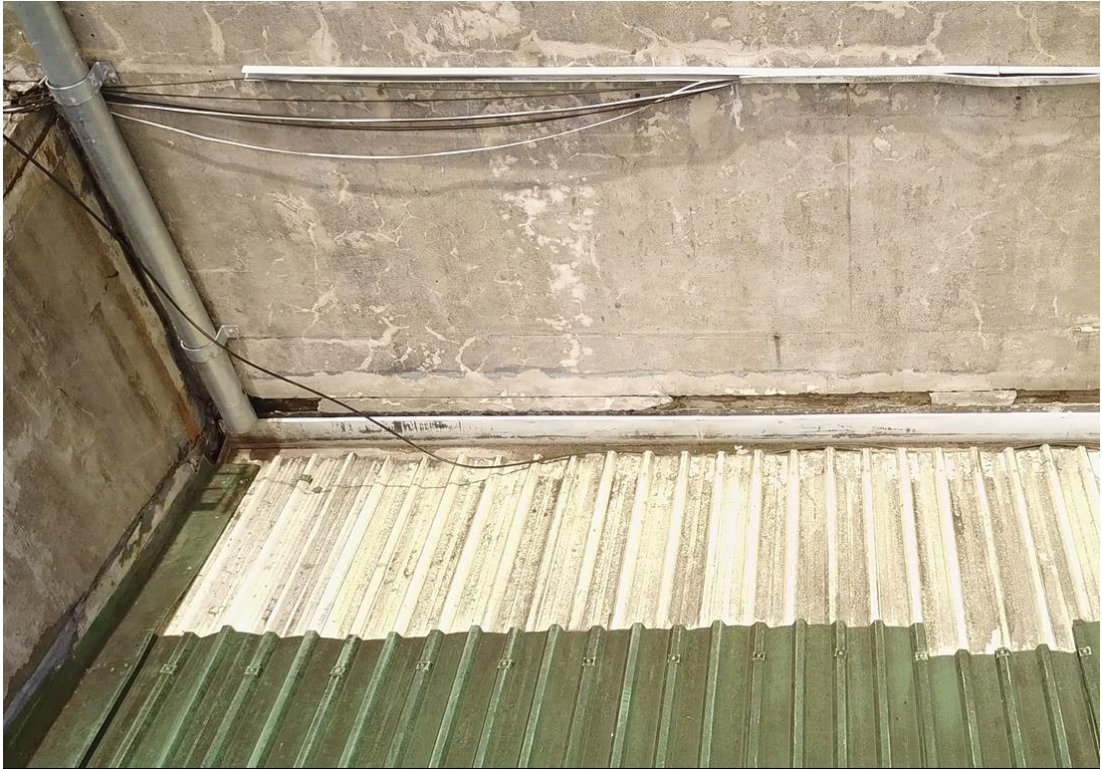
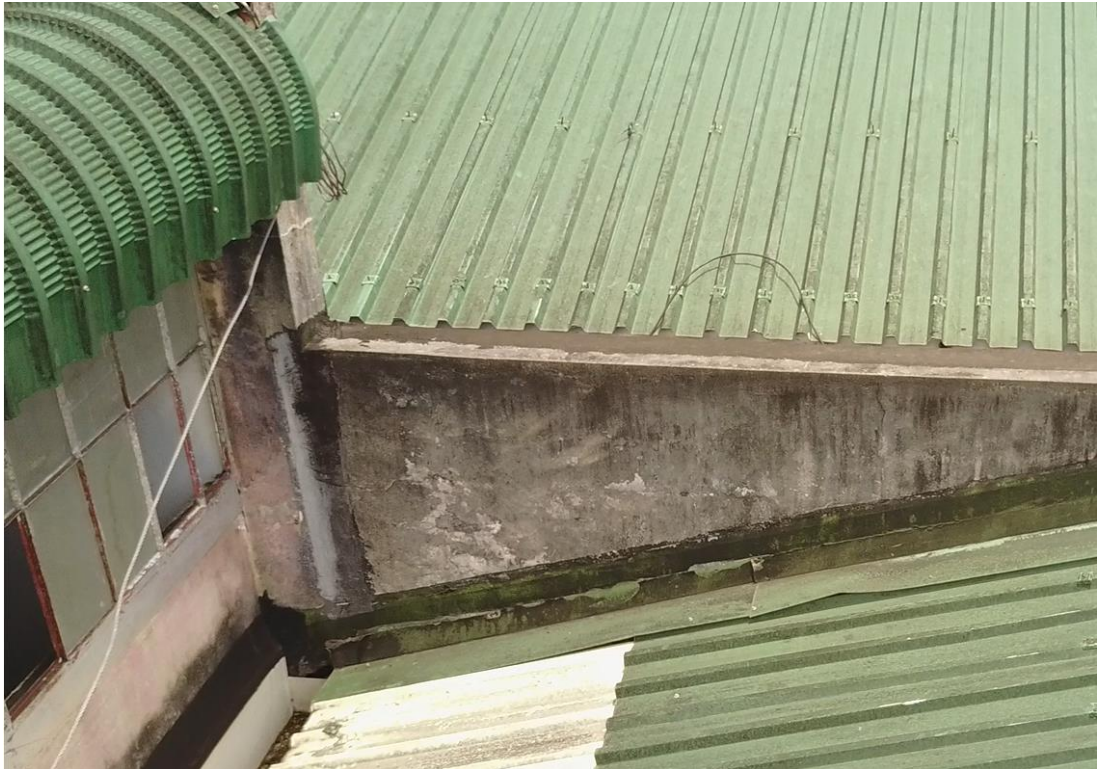
The gutters are in a very poor condition and must be replaced. Their condition allows water into the building which presents a risk to the occupants, the property and the hygiene of the products. Some of the windows at the top of the walls are broken also allowing water inside the building. These issues should be addressed.

26. Pack Hall: gutter and waterproofing in poor condition

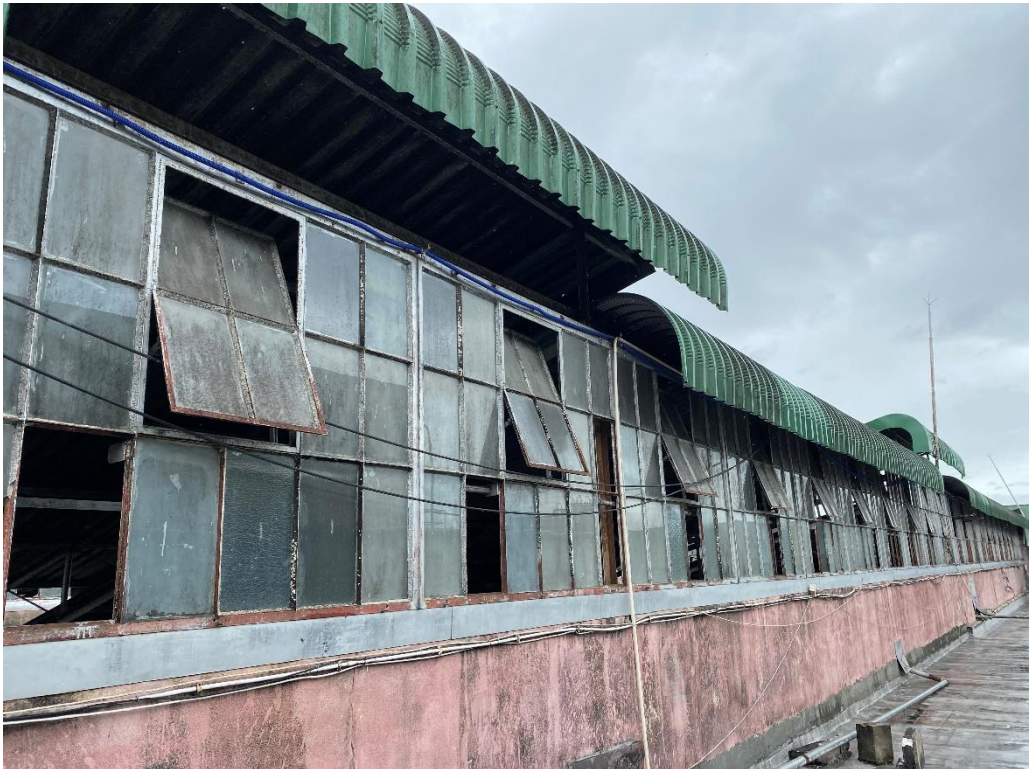
28. Pack Hall: broken windows

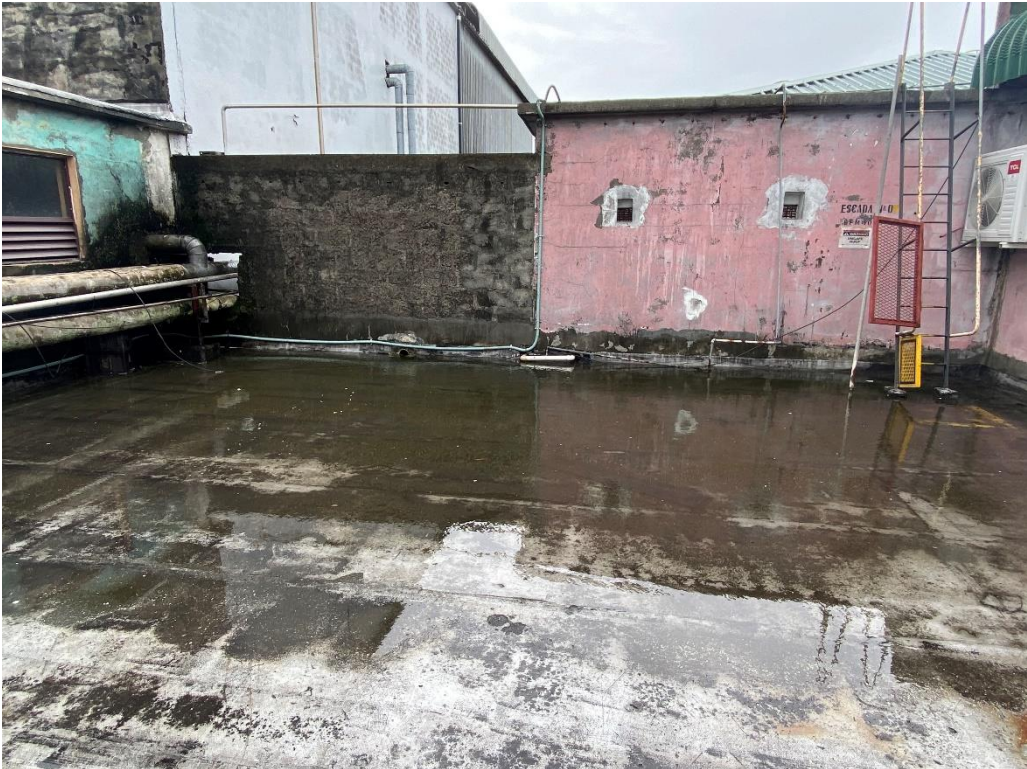
29. Pack Hall: poor drainage system on the roof slab

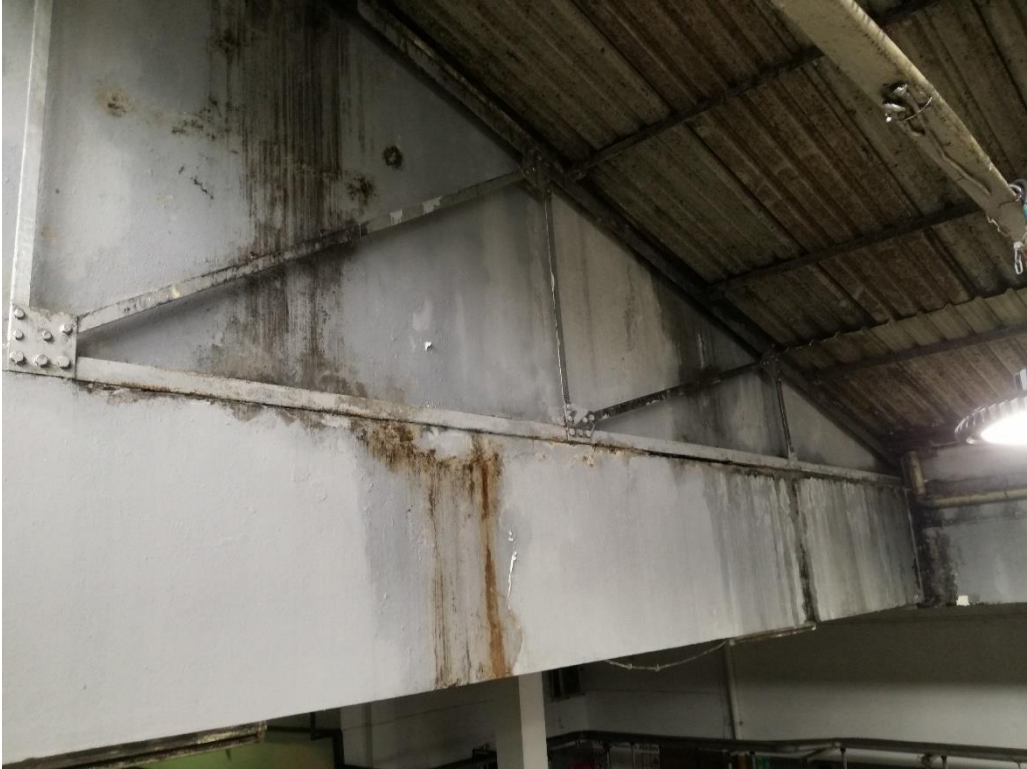
The roof slabs have severe cases of infiltration, this must be treated and waterproofing applied.

30. Pack Hall: Water Infiltration Due to Defective Waterproofing

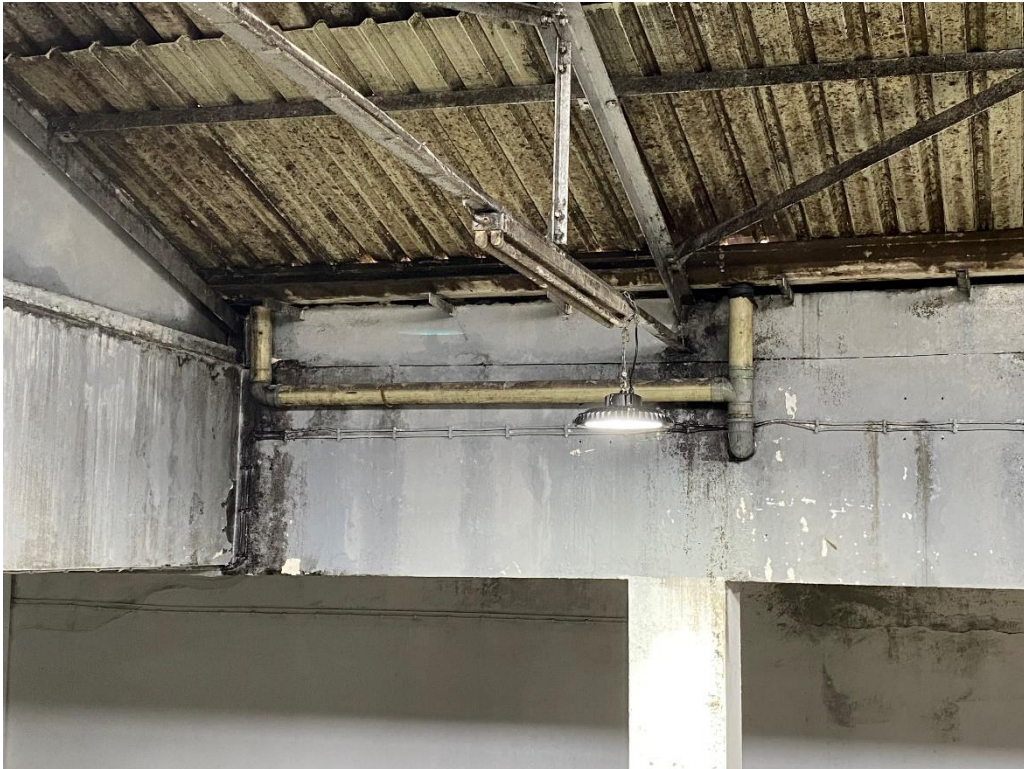
The roofing sheets are worn, and the steel elements show signs of corrosion. The gutters are in an advanced state of degradation with several points of corrosion. It recommended that the whole roof structure and drainage system are replaced.

31. Pack Hall: gutter in degrading condition

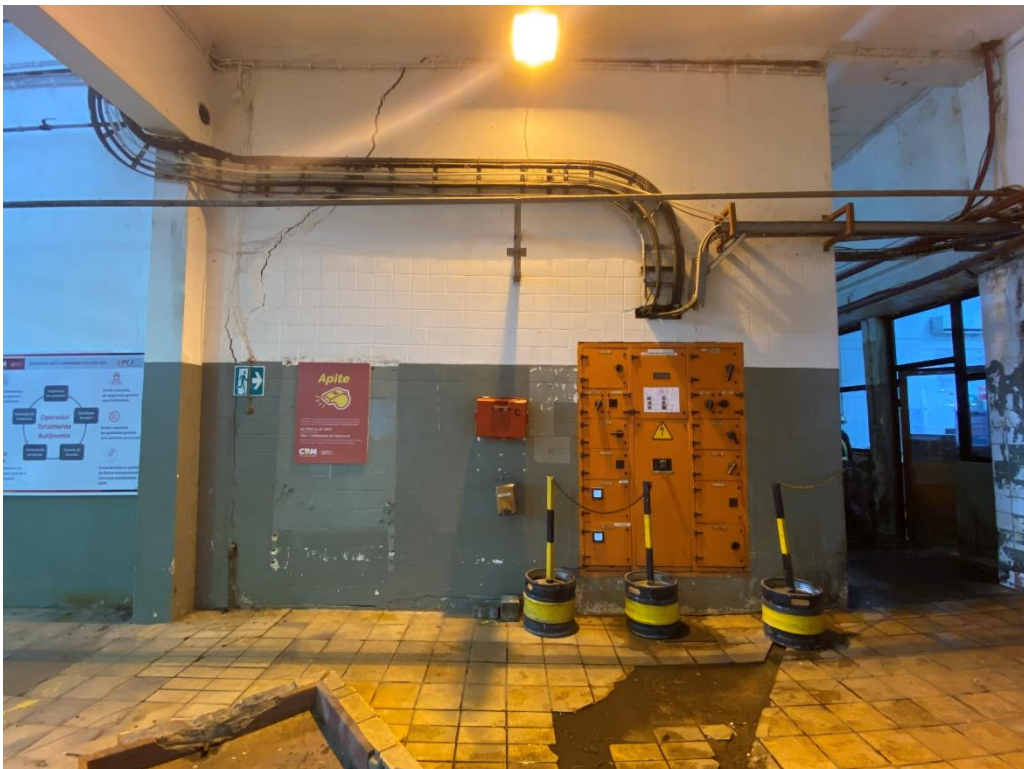
What is more concerning about this building are the cracks on the walls of the chlorine dosing room. There seems to be differential settlement of the building as the floor is visibly lower and cracked which caused one wall to rotate, thus cracking and disconnecting from the top slab. Specialized tests must be done to determine the extent of the damage and the affected walls must be rebuilt. It is not recommended to use these rooms while the walls are in this state as it represents great danger to the people working close to it.

32. Pack Hall: cracks in the walls and visible settlement of the floor

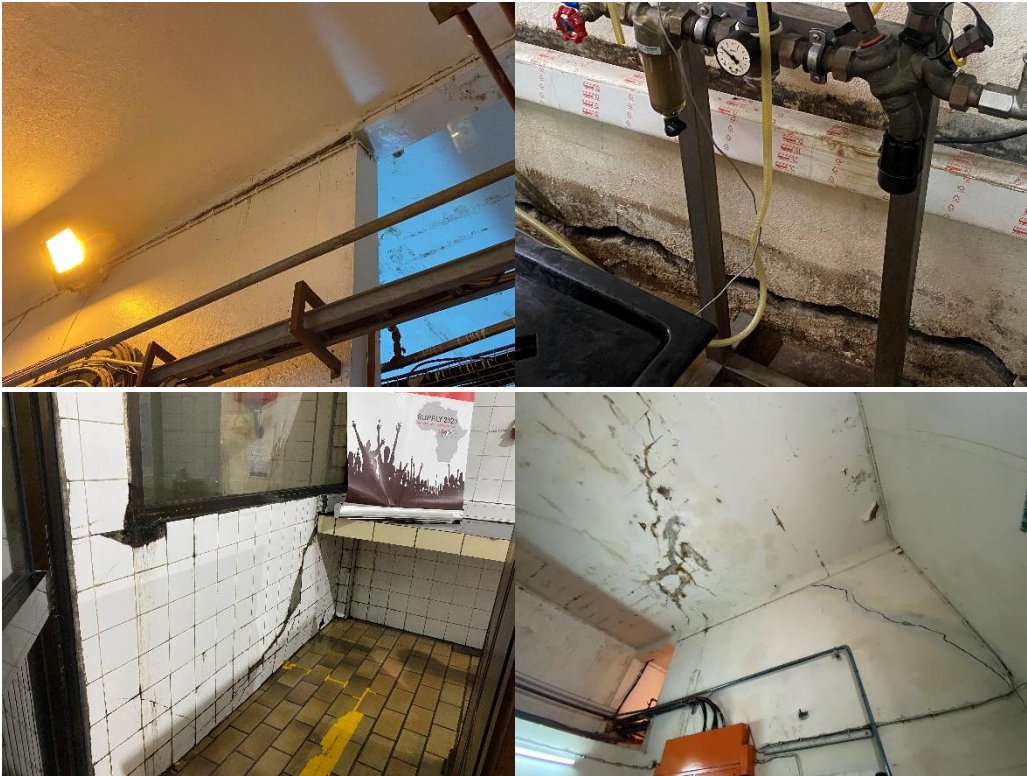
33. Pack Hall: detachment of the wall, cracks and water infiltration

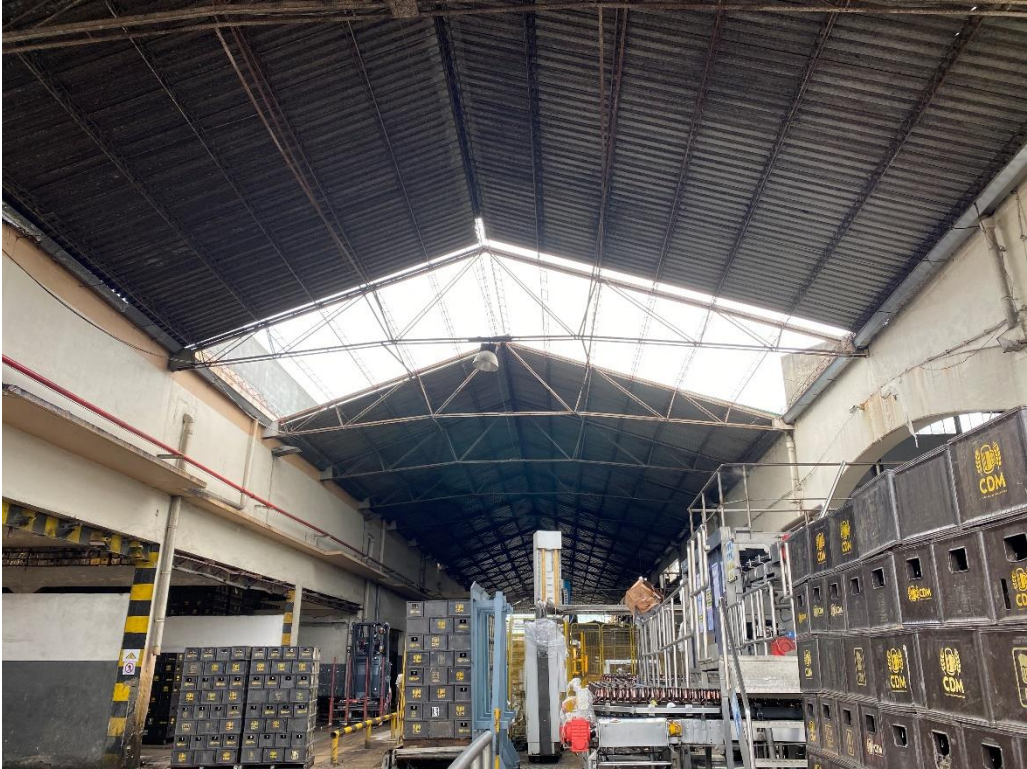
34. Pack Hall: part of the tunnel uncovered

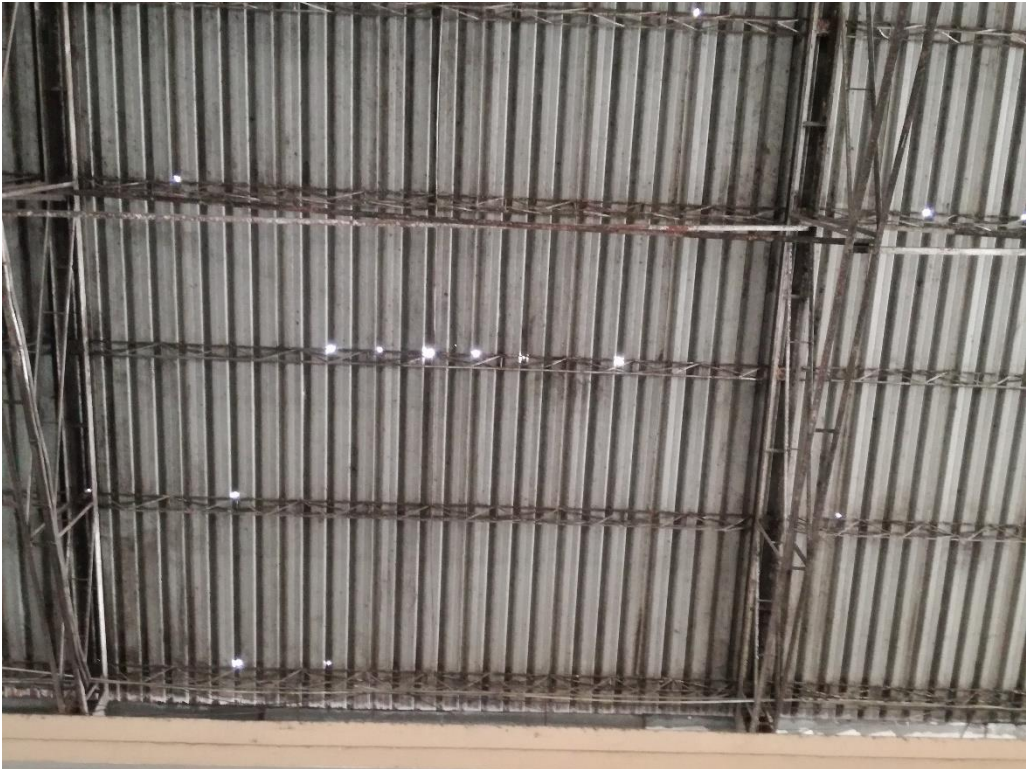
The Pack Hall represented in area number 7 of figure 2, has many problems including corrosion of steel elements, infiltration and the rainwater collection system that is inefficient. Although the roof trusses show signs of corrosion, this is not severe and may be treated, however, the roof sheeting must be replaced.

35. Pack Hall: roof with signs of corrosion

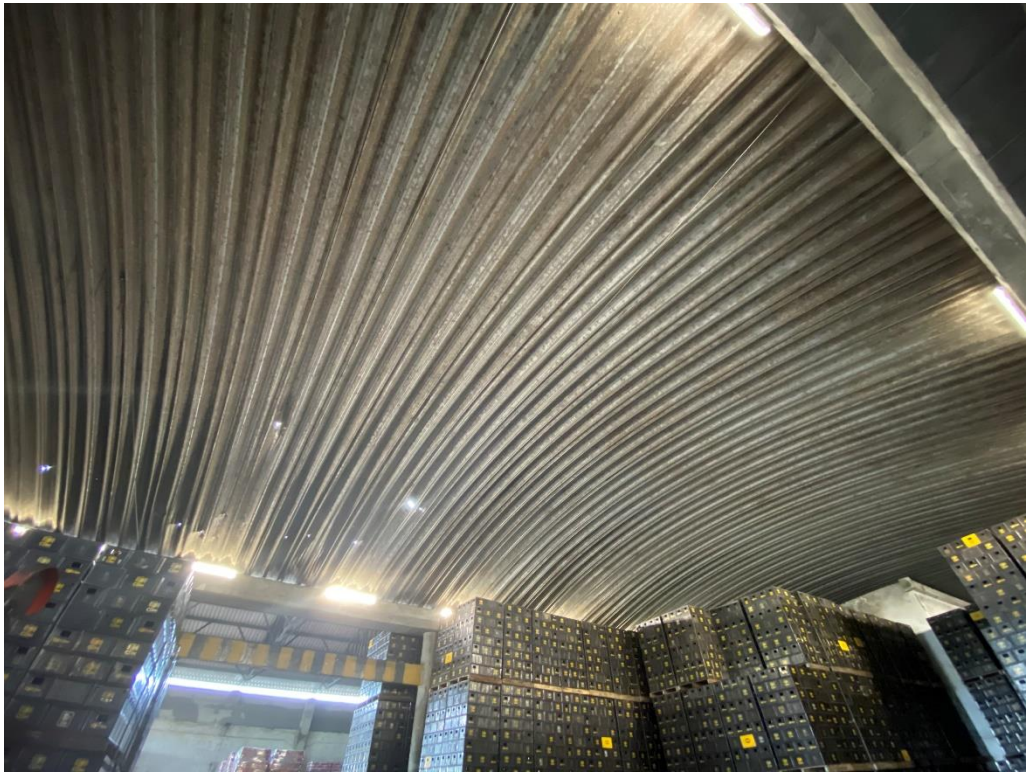
The Finished Goods warehouse has an old self-supporting roof structure that shows many signs of corrosion, there are visible holes in the roof. It is recommended that this structure is replaced by a new one similar to the fulls warehouse.

38. Finished Goods Warehouse: self-supporting roof structure with signs of corrosion

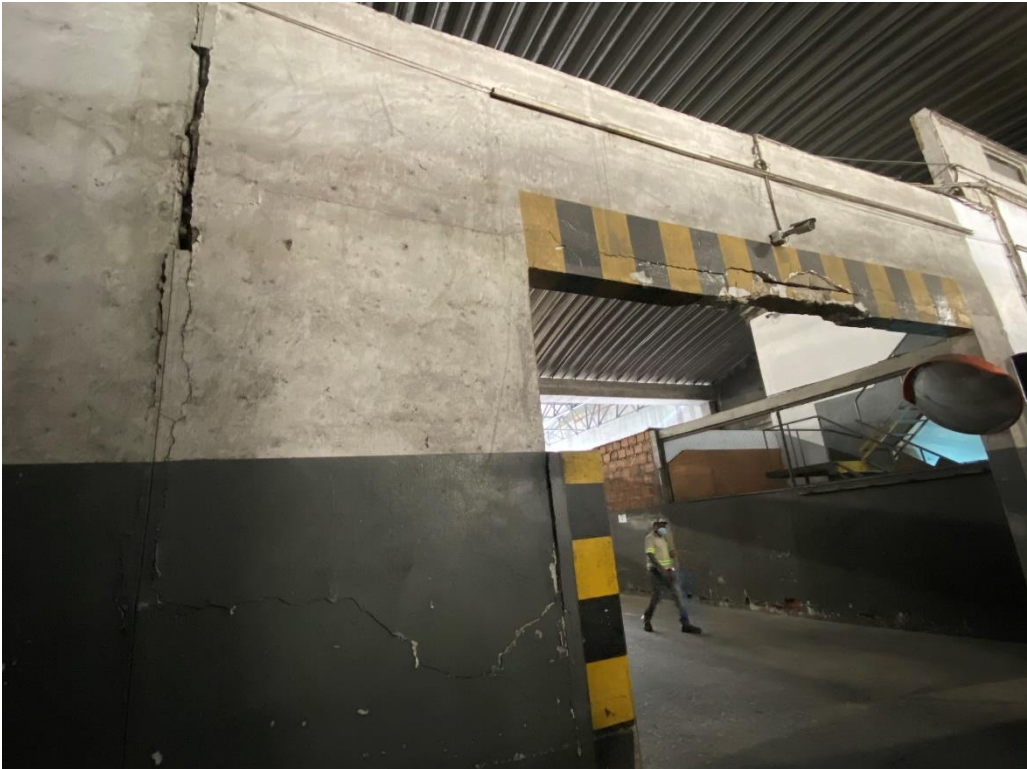
It was noted that a concrete beam covering one of the spans has been hit and is severely damaged and it has also caused cracks on the wall. It is recommended that demolition of this part of the wall including the concrete beam.

39. Finished Goods Warehouse: cracks in the beam and wall
