# Cervejas De Moçambique Structural Roof Assessment

Client: Cervejas De Moçambique

Reference: KA1831-RHD-ZZ-XX-RP-Z-0001

Date: 2/25/2021

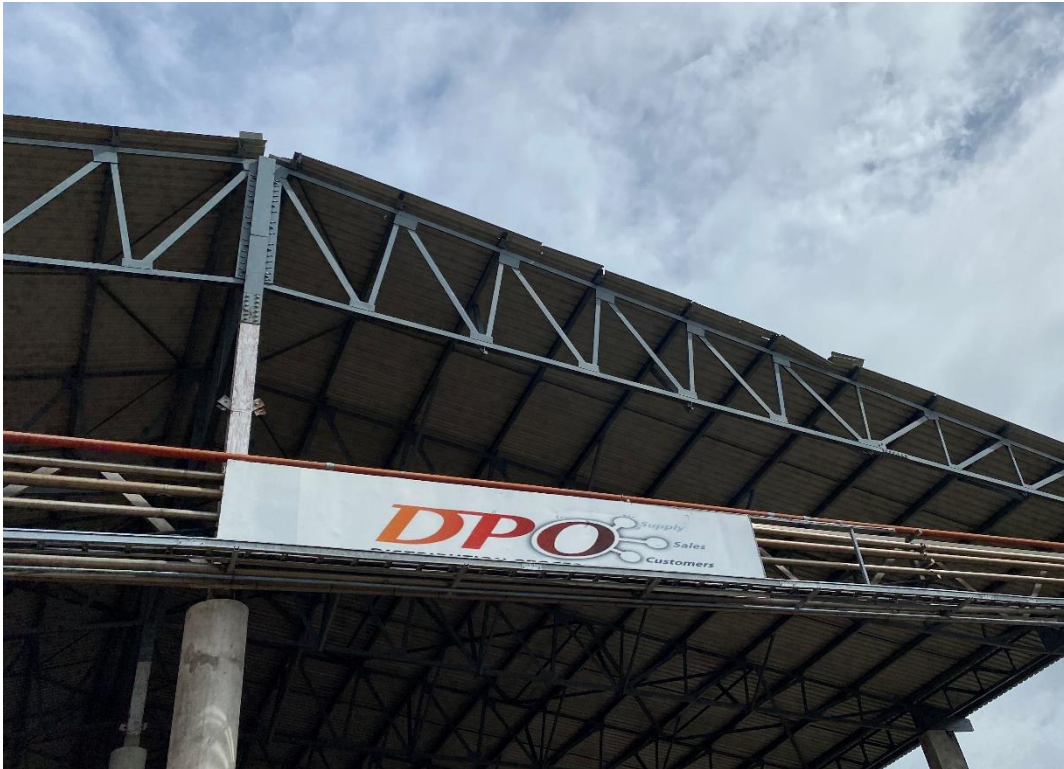
This section was recently rebuilt, the roofing sheeting, structural elements and gutters are new. Some problems were noted after the cyclone, including the ridge cap that was affected; a small section disintegrated from the attachment point. This type of damage was also seen with sections of the roofing sheeting. It is recommended that the roof sheeting affected is replaced with thicker sheeting and a new ridge cap is installed.

41. Un/Loading Bay – North: new roof with torn sheets at the end and missing ridge cap

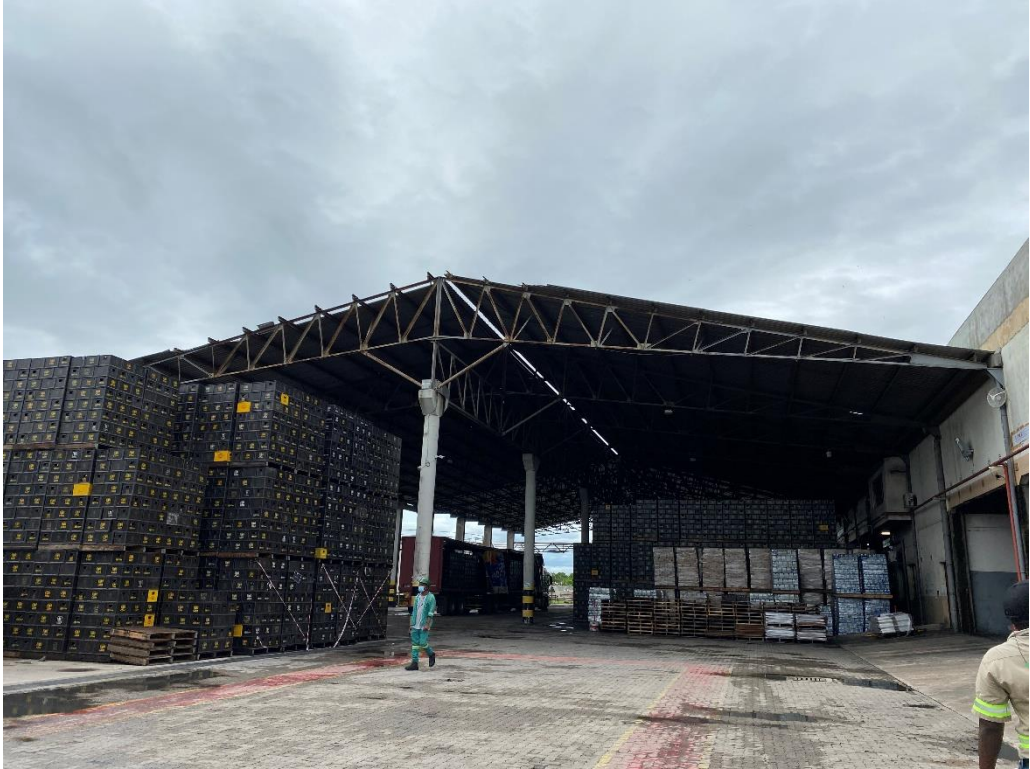
This section of the Un/Loading bay was not rebuilt and during the last cyclone the ridge cap was blown off by the wind leaving an opening thus allowing water to enter through this open area to the operation zone. It is visible that the roof sheeting has degraded from corrosion. Little holes can be seen in the roof. The steel structure also show signs of corrosion. The structural roof elements can be treated against corrosion but the roof sheets and gutters must be replaced, and a ridge cap installed.

42. Un/Loading Bay – South: roof missing the ridge, torn sheets and corroded roof structure

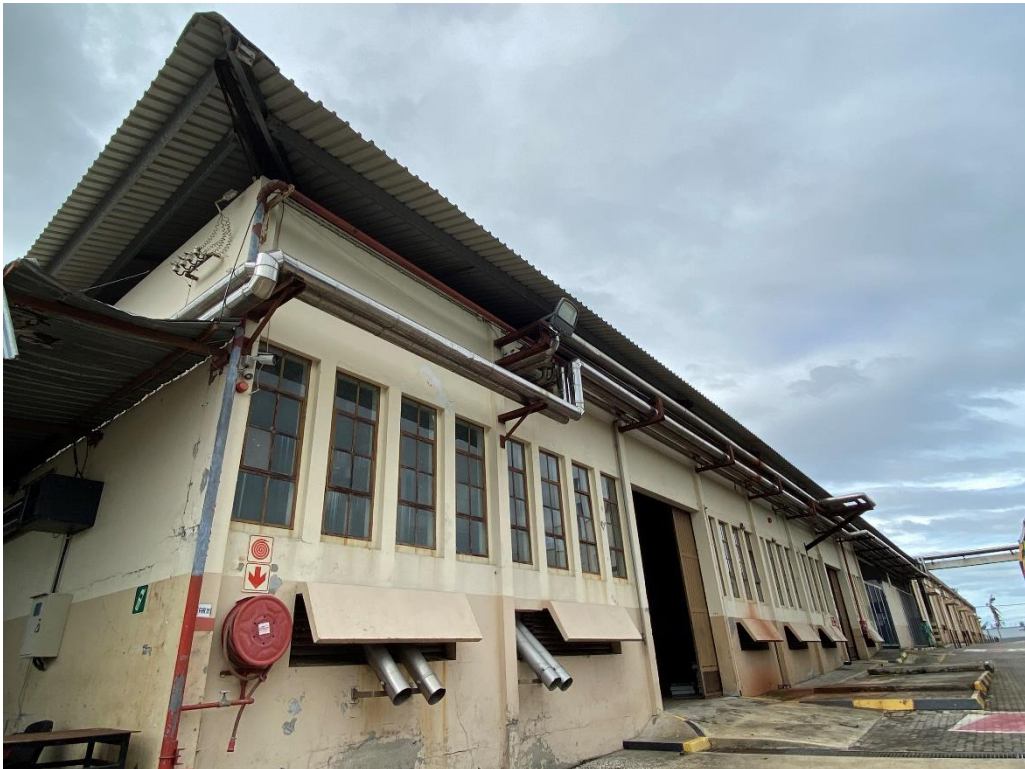
The roof structure of the Old Chibuko House was recently re-built and changed from wood to steel trusses. There is no rainwater collection system through gutters. There is a significant overhang of the roof and the last purlin is not supported by the roof truss. This may cause suction and potential up-lift of the roof. A design review of the new roof structure should be performed to determine the potential up-lift of this roof during a cyclone.

48. Old Chibuko House: long overhangs

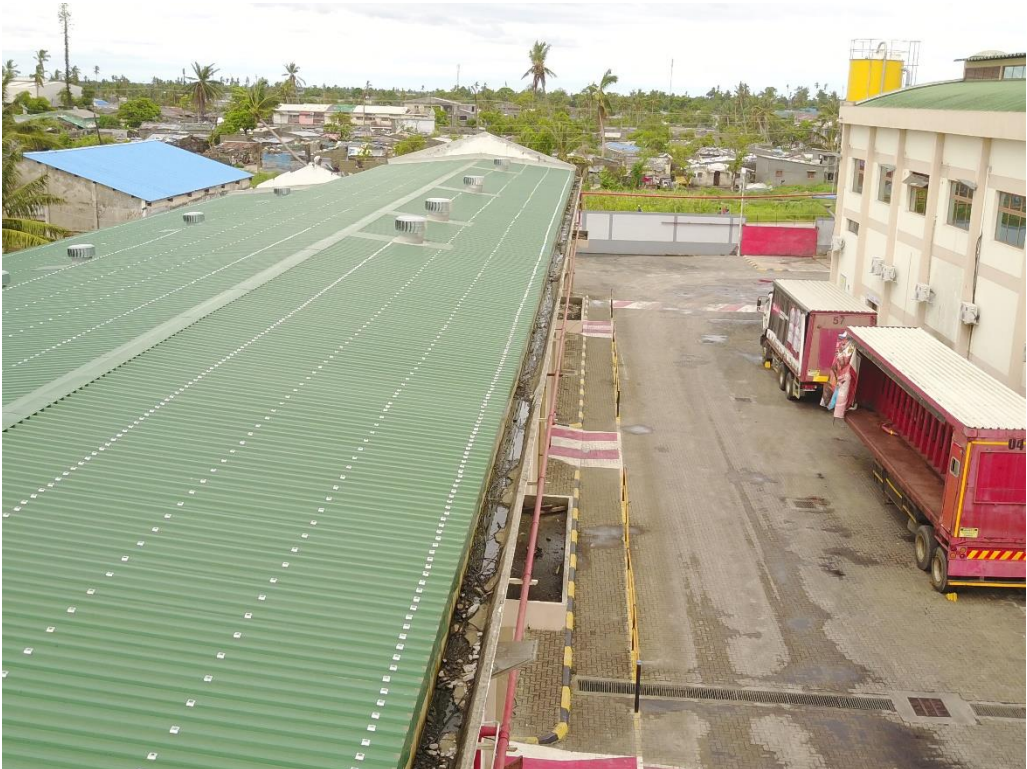
years and do not seem to be functional resulting in infiltration into the building. These gutters need repairs and waterproofing.

50. Raw Materials Warehouse: concrete gutter in poor condition

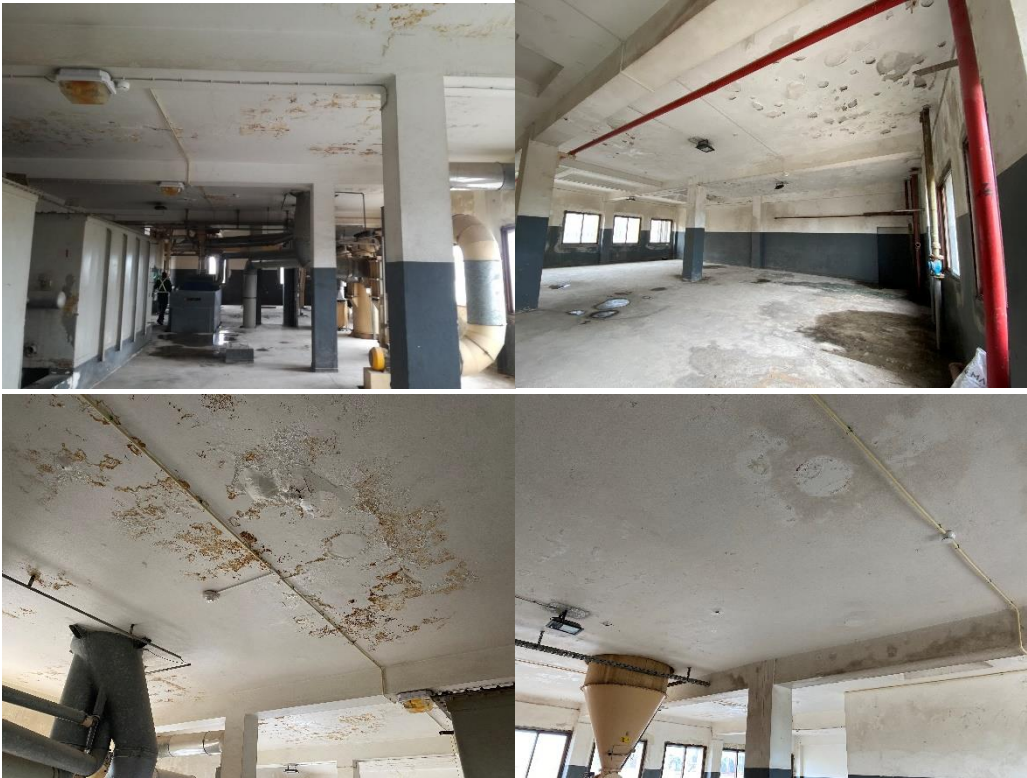
The silos building has a concrete roof slab and the waterproofing is in poor condition. There are signs of accumulated humidity, some portions are raised with air pockets and are loose. For these reasons the ceilings below present accentuated stormwater infiltration. The infiltration must be treated, and a new waterproofing membrane must be installed.

52. Silos Building: water infiltration in the slab soffit (different floors)

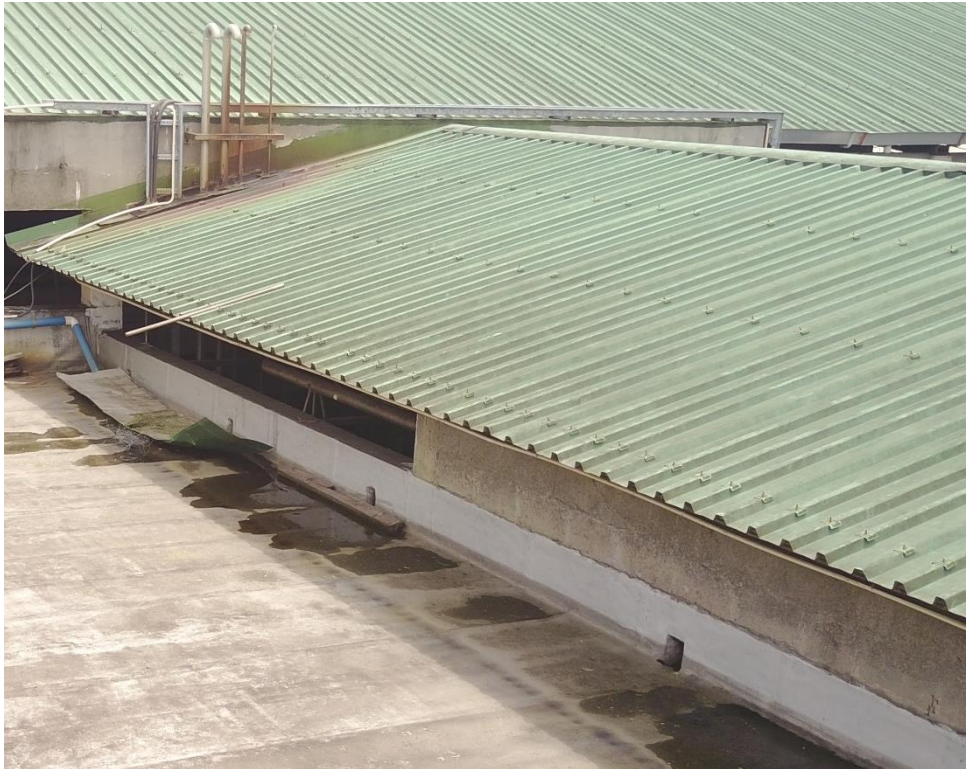
53. CO<sub>2</sub> Plant: opening that allows rainwater inside the building

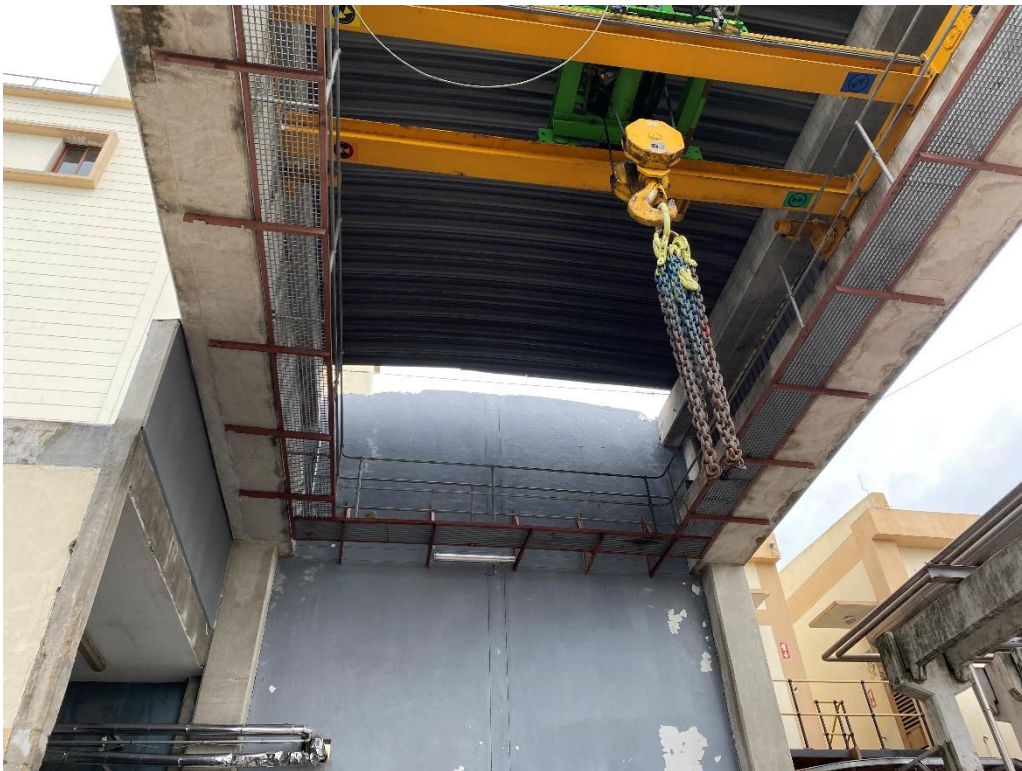
The roof of the Malt Intake is an old self-supporting structure that has signs of corrosion and was affected by the cyclone. One of the roof sheets was blown off by the wind leaving an opening on the roof. The roof sheet must be replaced.

54. Malt Intake: uncovered portion of the roof

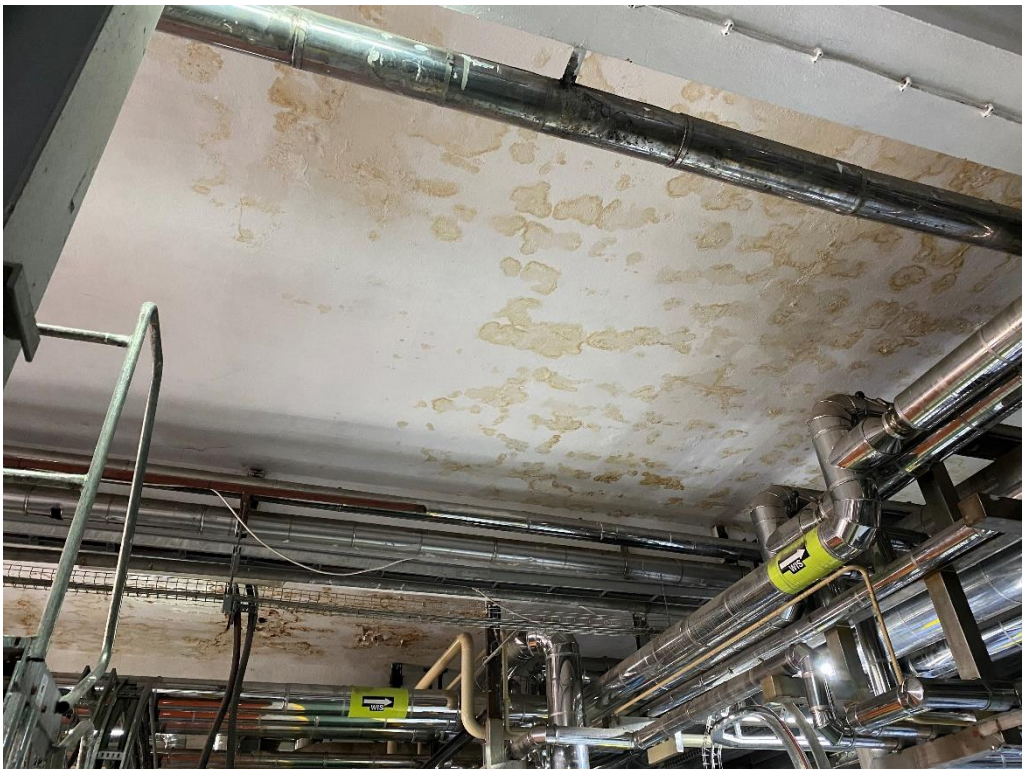
The Engine Room has a concrete roof slab and the waterproofing is in poor condition. There are signs of accumulated humidity, some portions are raised with air pockets and are loose. For these reasons the ceilings below present accentuated stormwater infiltration. The infiltration must be treated, and a new waterproofing membrane must be installed.

56. Engine Room: water infiltration in the ceiling

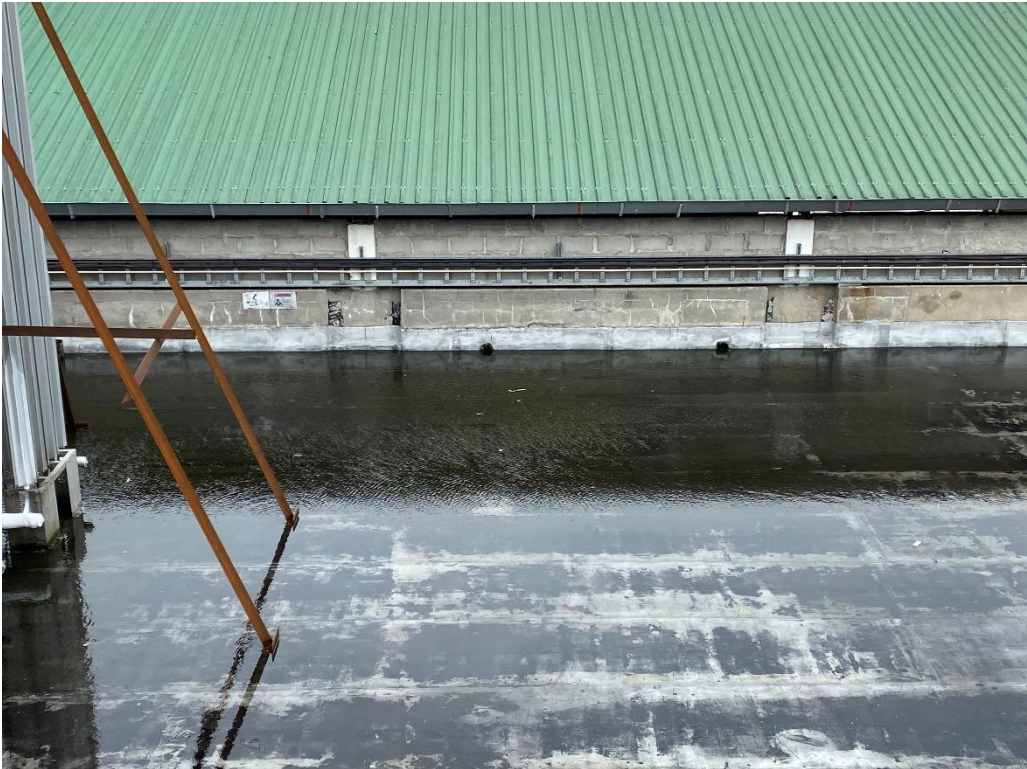
57. Engine Room: roof slab with inefficient drainage system

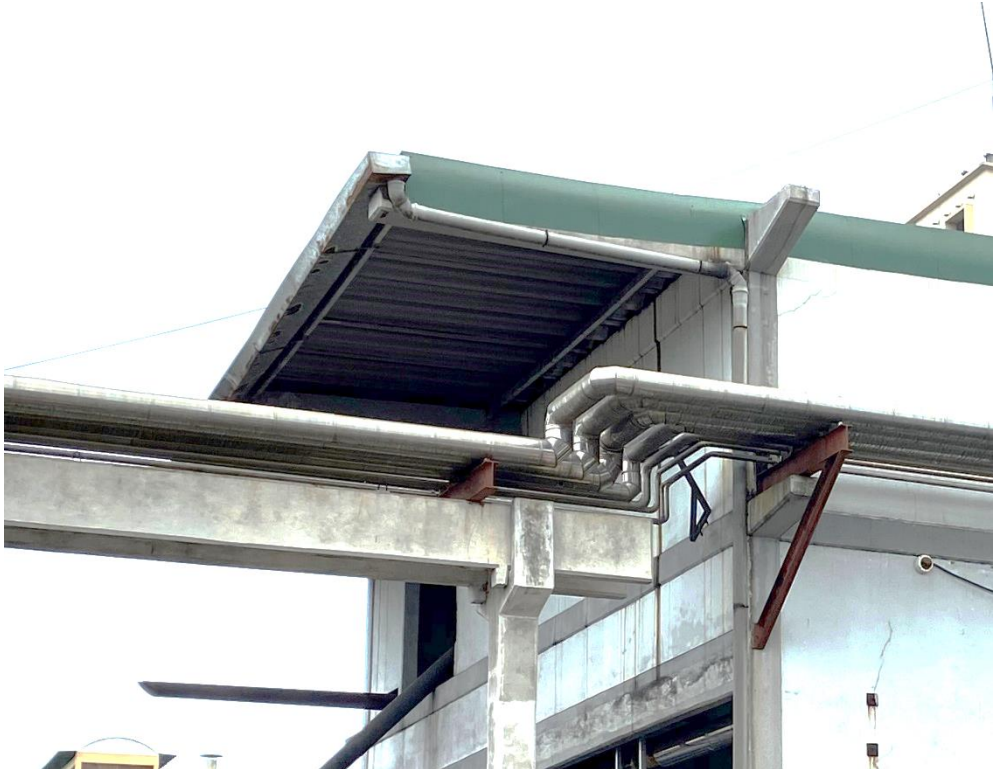
The roof and gutters of the Boilers are in a degraded condition, showing a lot of corrosion. The roof sheets and gutter need replacement. The roof structural elements also show signs of corrosion but could not be properly inspected due to inaccessibility. Extensive replacement of the whole roof may be required if found inadequate.

59. Boilers: corrosion in gutter and roof

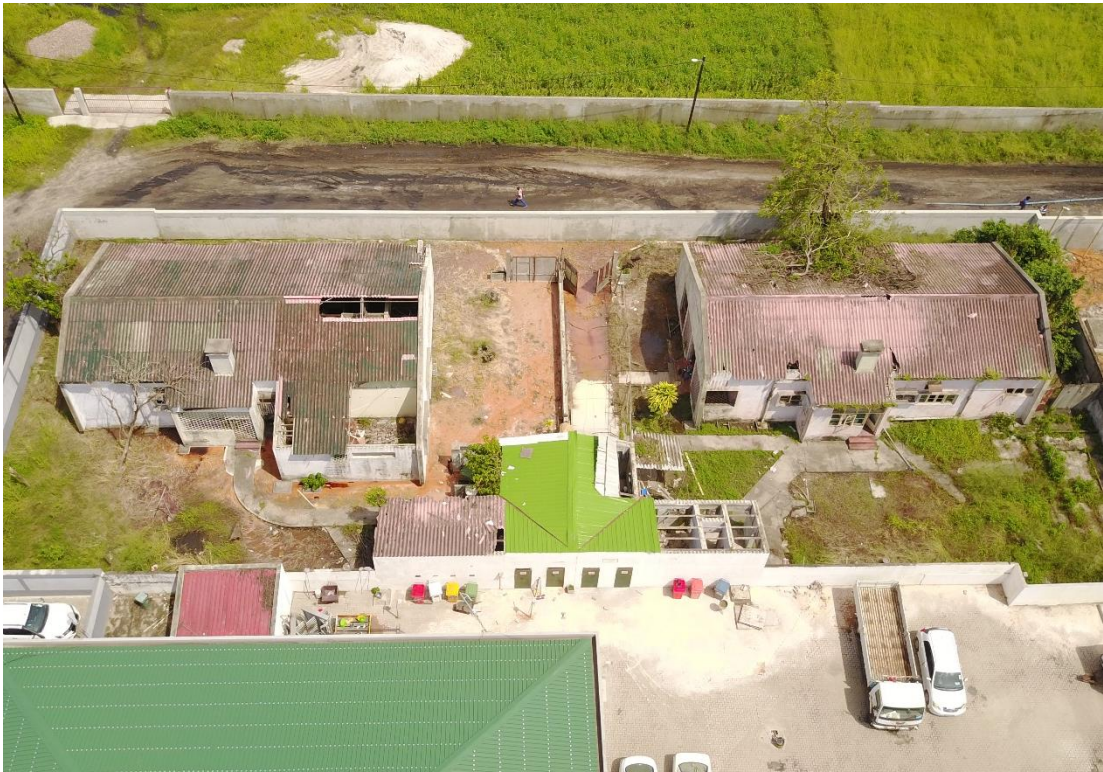
The Residence 1 is not in use and was not part of the guided visit but it is property of CDM hence the drone was used to inspect it. Parts of the roof is missing which indicated that stormwater goes into the building when it rains. The whole house needs rehabilitation and the roof structure should be replaced.

60. Residences: roofs in advance state of degradation
