Method Statement for Roof Repairs

Client: Cervejas De Moçambique

Reference: KA1831-RHD-ZZ-XX-RP-Z-0002

Project name: Cervejas De Moçambique Structural Roof Assessment

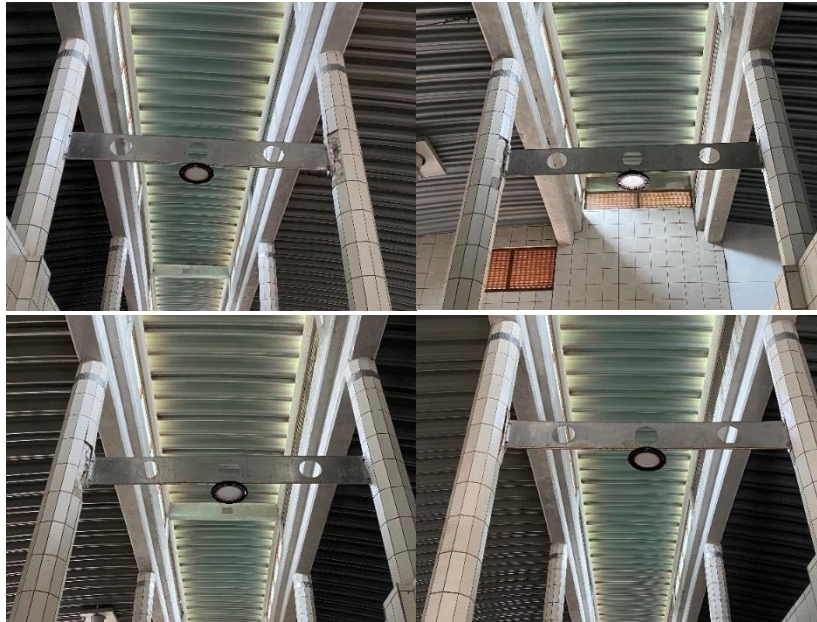
- Infiltration on the staircase.
- Water dripping from the ceiling on rainy days in one office.
- Movement of concrete columns causing concrete detachment.

Figure 1: Brew House - Damaged concrete columns

1. Behavioural tests shall be performed to determine the causes of the damage (it is difficult to establish it from a visual inspection only), whether the concrete columns have shifted, or the beams are pulling out and if the integrity of the structure has been compromised.

2. Monitoring tests shall be performed to indicate the extent of the damage and if there is still movement in the structural elements.
3. Based on the results obtained from the tests above, a contractor shall be appointed to execute the repairs to the damaged elements using structural repair mortar and reinforce the connections. In case of a compromised structural integrity, reinforcing elements shall be added to the structure.

4. When repairing the concrete, these steps should be followed:
 - i. Select the repair method and material
 - ii. Prepare the existing concrete for repair

- iii. Implement the repair method
 - iv. Cure the repaired area properly

It is recommended to use an experienced laboratory to perform the tests for structural integrity (concrete resistance and movement monitoring), such as LEM, or similar approved by the structural engineer.

The contractor shall submit technical specifications of the material to be used for structural repair, for approval. In the case where additional reinforcing elements are required, carbon strips may be an option.

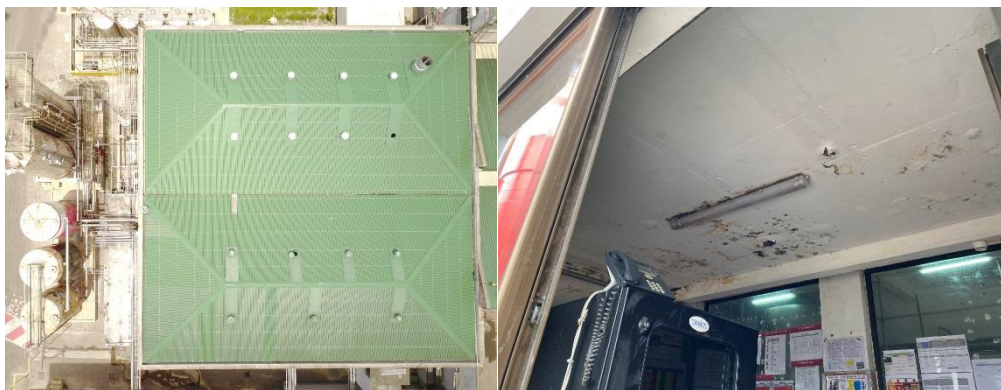
- Gutters lacking maintenance.
- 3 whirlybirds misplaced.
- Worn waterproofing membrane.
- Infiltration on the slab soffit.

Figure 2: Canteen and Filtration – Anomalies

1. The gutters and down pipes should be accessed and cleaned. Any obstructions and vegetation found must be removed.
2. 2 of the 3 whirlybirds have the covers misplaced but there are on the roof, therefore it only needs to be accessed and put in place.

3. The third and large whirlybird is uncovered. After accessing the roof, the technician shall determine what is missing from the cover to replace it.
4. The waterproofing membrane on the Filtration roof slab is worn and should be replaced. A Contractor shall be appointed to remove the existing waterproofing membrane and install a new waterproofing system. The contractor must present beforehand the technical specifications of the waterproofing material they intend to use, for approval.

5. The slab soffit with signs of water infiltration must be cleaned and where necessary, repaired. In places with severe signs of damage due to water infiltration, the integrity of the concrete shall be determined by testing the degree of corrosion of the steel reinforcement in the slab.

It is recommended that maintenance of the gutters is done at regular intervals. A map can be drawn to schedule the dates for the maintenance.

It is recommended that the areas with visible signs of water infiltration are examined to determine if there are other causes for water infiltration besides the poorly maintained gutters and the worn waterproofing membrane, like leaking pipes.

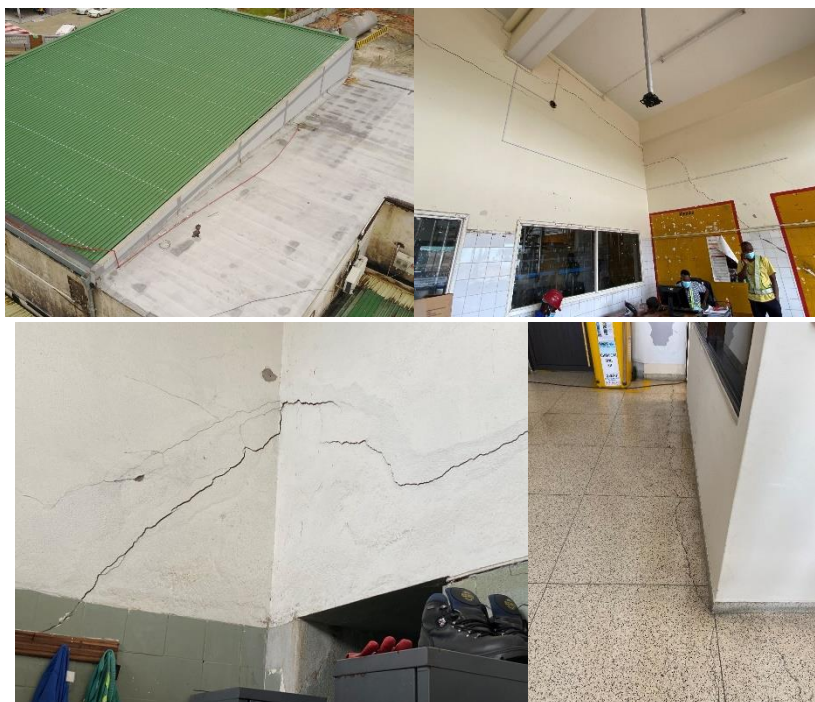
- Infiltration on the slab soffit and walls.
- Missing lateral roof flashing.
- worn waterproofing membrane on the roof slab.
- Poor sealing between the wall of the technical building and the roof of the pack hall.
- Cracks on the 1st floor slab.
- Large cracks along the walls.

Figure 3: Laboratory / Technical Building – Anomalies

1. The waterproofing membrane on the roof slab should be replaced. The Contractor must remove the existing waterproofing membrane and replace it with a new waterproofing system. The contractor must present beforehand the technical specifications of the waterproofing material he intends to use, for approval.

2. The slab soffit and walls with signs of water infiltration are to be cleaned and where necessary, repaired. In places with severe signs of damage due to water infiltration, the integrity of the concrete shall be determined by testing the degree of corrosion of the steel reinforcement in the slab.

3. A new lateral roof flashing must be installed where it is missing.
4. The joint between the wall of the technical building and the roof of the pack hall allows the rainwater through therefore must be sealed with a proper sealant to be proposed by the Contractor. The affected wall is to be cleaned, possibly scarified and a new plaster and paint applied.

5. From the visual inspection it is difficult to establish the exact cause of the cracking therefore a qualified laboratory should be appointed to perform tests such as soil compaction and concrete resistance to further investigate. This will allow for a more qualified opinion of the structural integrity and safety of the structure and the method of repair.

It is recommended the use of an experienced laboratory to perform the tests such as LEM or similar approved by the structural engineer. The testing should be done as soon as possible to determine whether it is safe to keep using the space while the rehabilitation work do not start.

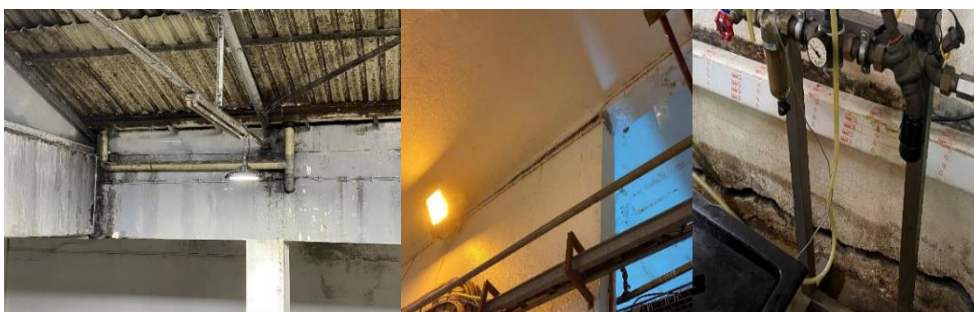
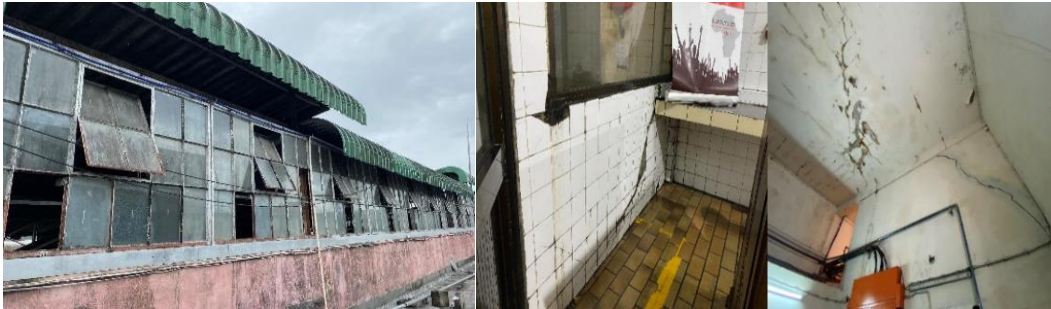
- Missing part of the roof, leaving it open and exposed to all weather conditions.
- Corrosion of roof steel elements.
- Infiltration on the ceiling and walls.
- Gutters in poor condition causing the water to pour inside the building on rainy days.
- Large cracks on the walls.
- Floor settlement.
- Detachment of the walls.
- Broken windows

Figure 4: Pack Hall – Anomalies

1. The entire roof should be replaced. A structural engineer should design a new roof structure able to withstand the winds of a cyclone.
2. New gutters must be designed to replace all the existing gutters.

3. The broken windows must be replaced.
4. A qualified laboratory must be appointed to material tests on the concrete to determine the extent of the damage of the roof slabs caused by water infiltration. It is likely that the roof slab needs to be repaired and reinforced as it shows signs of corrosion of the steel reinforcement inside the slab.

5. The laboratory must perform soil compaction tests to determine the cause of the cracks on the walls and the floor, as it is difficult to establish this only by visual inspection. The walls are severely damaged and detached from the structural elements therefore they must be demolished.

6. After the cause of the damage to the walls have been identified it must be addressed and resolved. In case of differential settlement, it can be fixed by concrete underpinning, jet grouting or extended geopolymers.

The area around the detached wall presents a risk to people therefore it is recommended that this area is isolated until it can be repaired.

It is recommended that the rehabilitation works are executed in phases to minimize the negative effect on the operations.

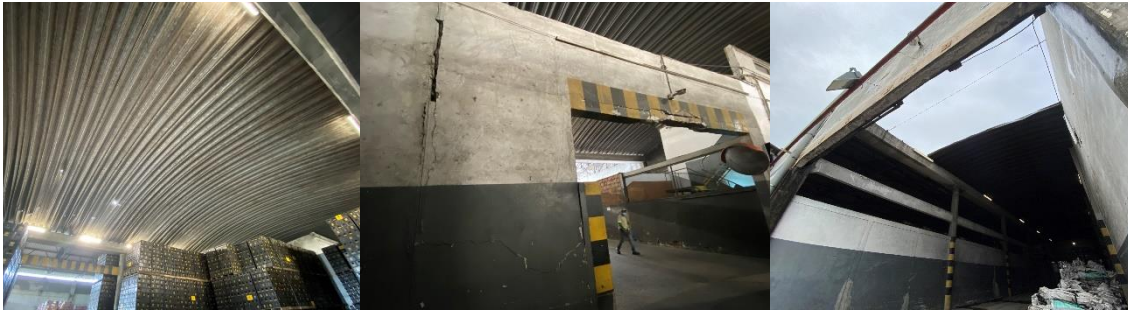
- Corrosion of the roof sheets.
- Damaged concrete beam and cracked wall.
- The roof between the empty bottles warehouse and the logistics meeting room shows signs of corrosion and has a portion of the roof missing, leaving an open space subject to all weather conditions.

Figure 5: Finished Goods Warehouse – Anomalies

1. The entire roof should be replaced. A Consultant, structural engineer should design a new roof structure able to withstand the winds of a cyclone.

It is recommended that the damaged beam and the wall inside that frame are demolished, leaving an open span.

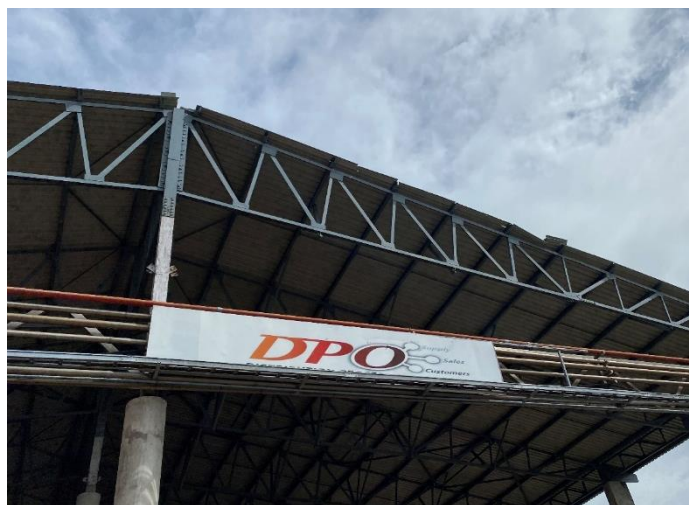
- Missing last portion of the ridge cap.
- Torn and detached end roof sheets.

Figure 6: Un/Loading Bay (North) – Anomalies

1. The damaged roof sheets should be replaced with new sheeting.
2. The end portion of the ridge cap must be installed.

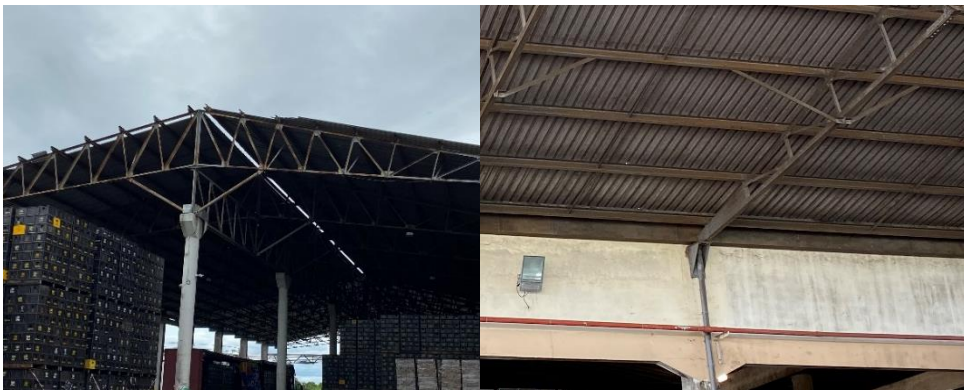
- Missing the whole ridge cap.
- Corrosion of all steel elements (holes in the roof).
- Gutters in degrading condition

Figure 7: Un/Loading Bay (South) – Anomalies

The rehabilitation will focus on the gutters and the missing ridge cap. The roof structure and roof sheets are not a priority at the moment and will be replaced gradually at a later stage.

1. A contractor must be appointed to supply and install the ridge cap.
2. A Consultant must design new gutters to replace the existing gutters.

Although a new roof structure is not urgent, it can be designed by the Consultant and reserved for when the time is appropriate to replace the existing one.

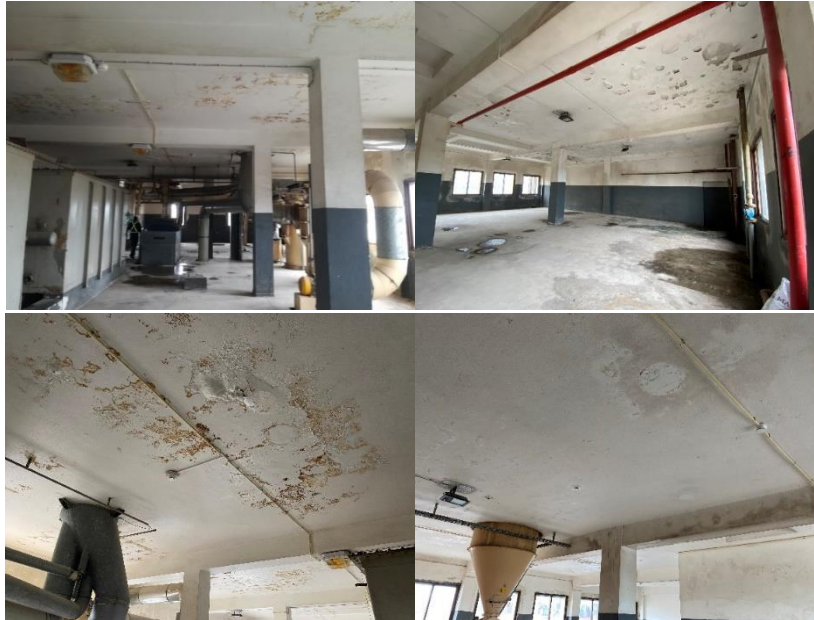
- Waterproofing of the roof slab in poor condition.
- Infiltration on the slab soffits.
- One lateral roof sheet missing in the adjacent building.

Figure 8: Silos Building – Anomalies

1. Material tests must be performed to determine the extent of the damage the water infiltration has caused in the slabs as it is difficult to establish this only by visual inspection. Repairs must be done according to the results obtained.
2. The building must be examined to determine the cause of the infiltration in the slabs.
3. The waterproofing membrane of the roof slab must be replaced with a new waterproofing system. The appointed Contractor must present beforehand, the technical specifications of the waterproofing material they intend to use, for approval.
4. The lateral roof sheeting of the adjacent building (malt crane area) must be replaced with a new one.

It is recommended that the gutter downpipes are inspected to identify any faults that might be causing the infiltration in the building.

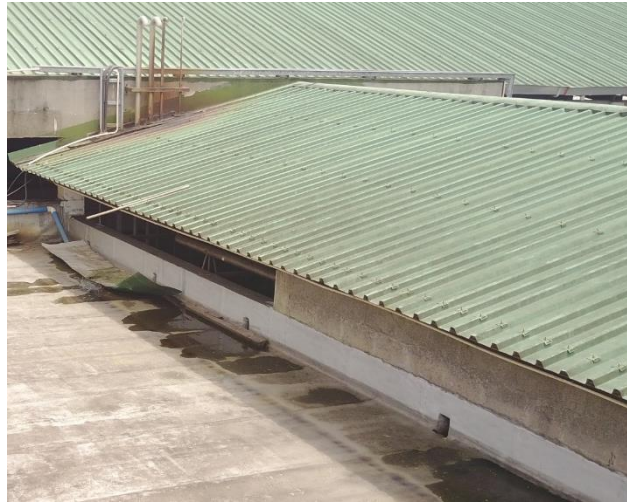
No anomalies found but there is a gap between the roof cover and the walls that allow the rainwater to pour in.

Figure 9: CO₂ Plant – Gap

1. CDM must determine whether this opening is a requisite for the operations taking place at the CO₂ Plant.
2. Glass shutters can be placed if the opening is indispensable.

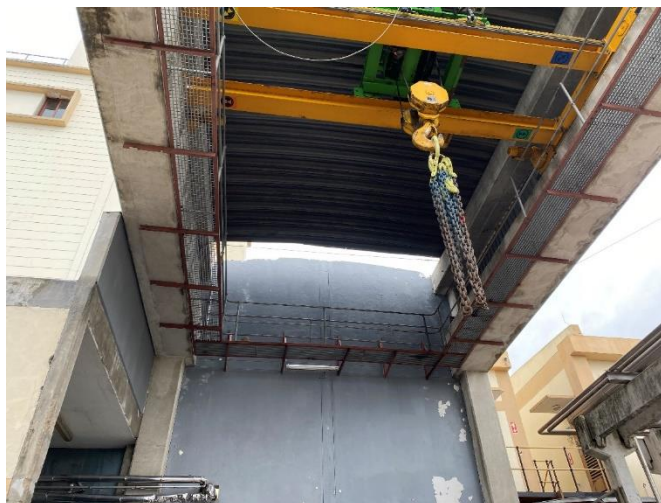
- Corrosion on the roof.
- Missing a portion of the roof.

Figure 10: Malt Intake – Anomalies

1. The roof supporting steel structure could not be inspected during the site visit due to inaccessibility, therefore it couldn't be determined whether it requires only treatment or replacement. It must be safely accessed using cherry picker for a proper inspection to determine whether it can be treated for corrosion protection or must be replaced.
2. The missing roof sheet must be replaced with a new one.
