# Cervejas De Moçambique Structural Roof Assessment

Client: Cervejas De Moçambique

Reference: KA1831-RHD-ZZ-XX-RP-Z-0001

Date: 2/25/2021

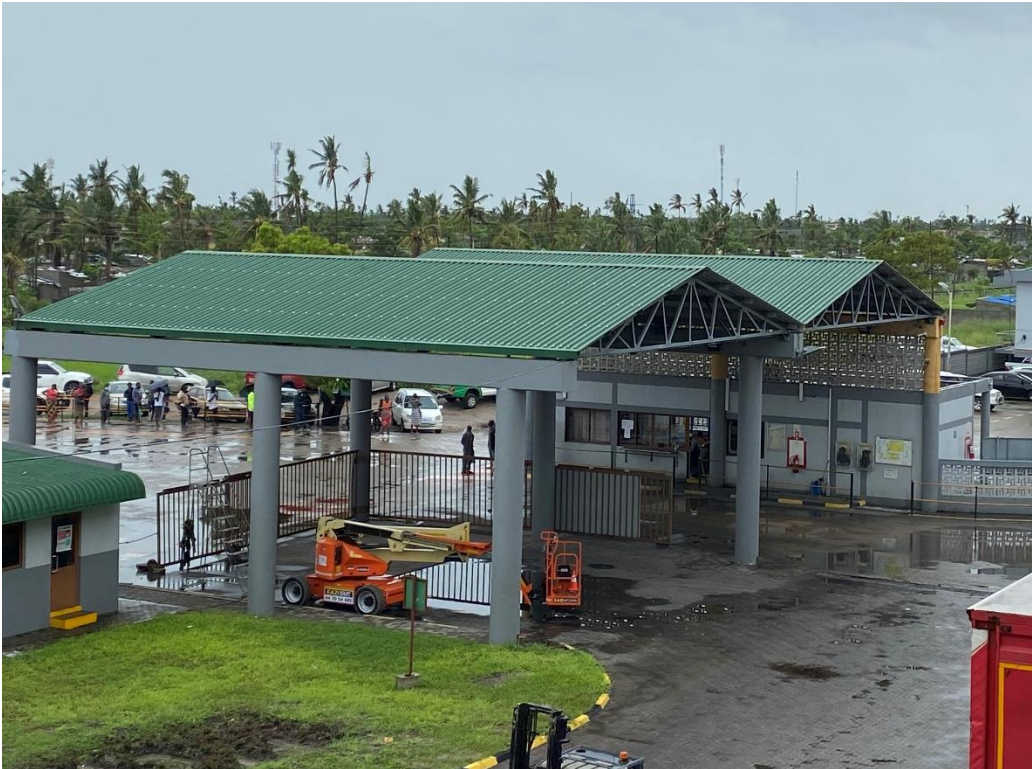
The Main Entrance is a new building and it showed no signs of damage. The roof structure and roof sheets are in a good condition and repairs are not necessary.

5. Main entrance

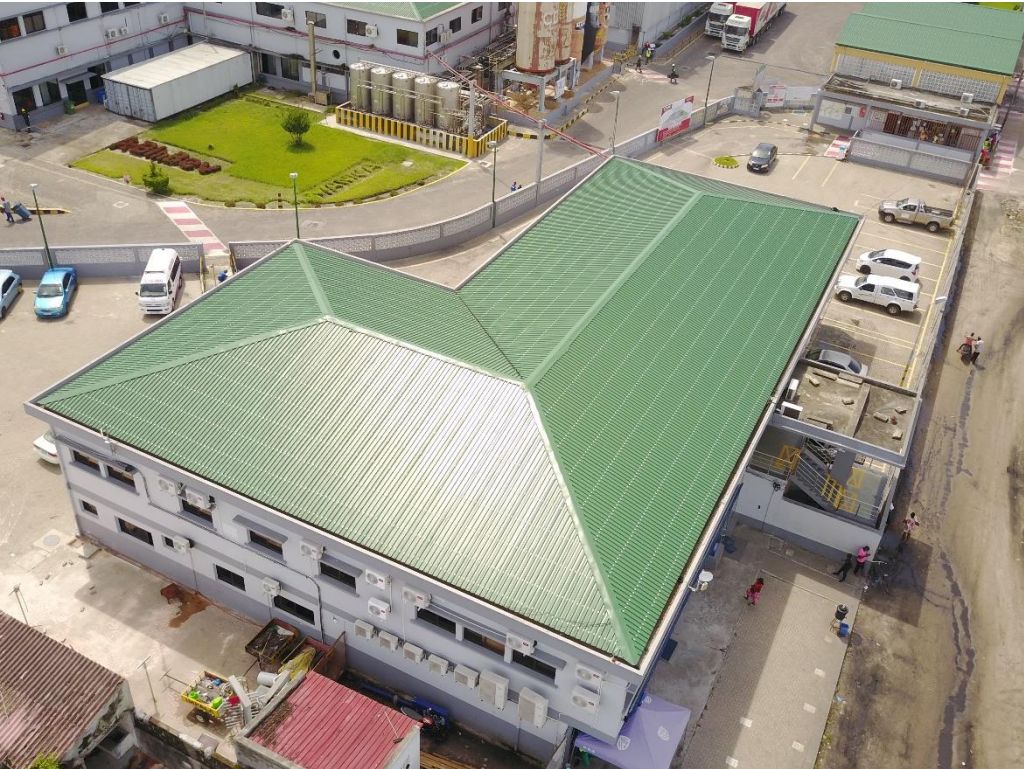
The Administration Offices, similarly to the main entrance, is also a new building. The roof does not present any damages and the gutters are functional. There is no need for any repairs.

6. Administration offices

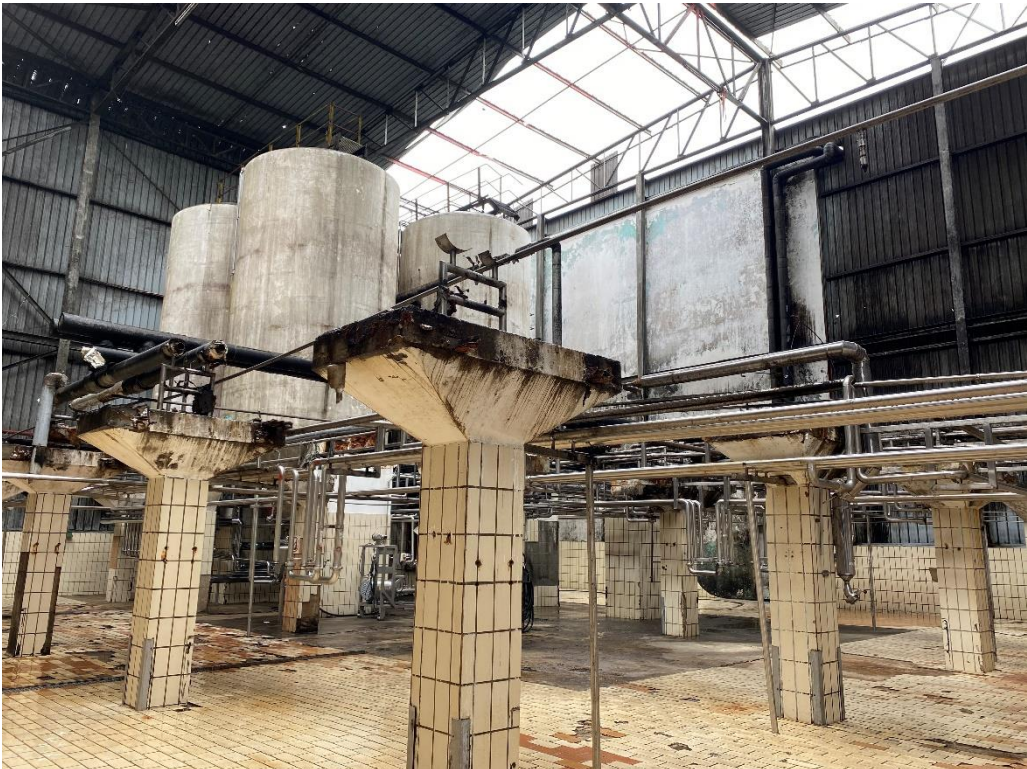
The Old Cellars is an old building (around 60 years old) and there seems to be no maintenance of its structure. It is one of the buildings that was most affected by the cyclones. Half of the roof sheeting is gone due to the strong winds leaving the roof structure exposed and the remaining roof sheeting is severely corroded.

12. Old Cellars: another view from inside the building

The roof trusses can still be used but need proper treatment and maintenance. The purlins and roof sheeting must all be replaced. There is currently no rainwater collection system, such as, through roof gutters and a completely new system of roof stormwater collection must be installed.

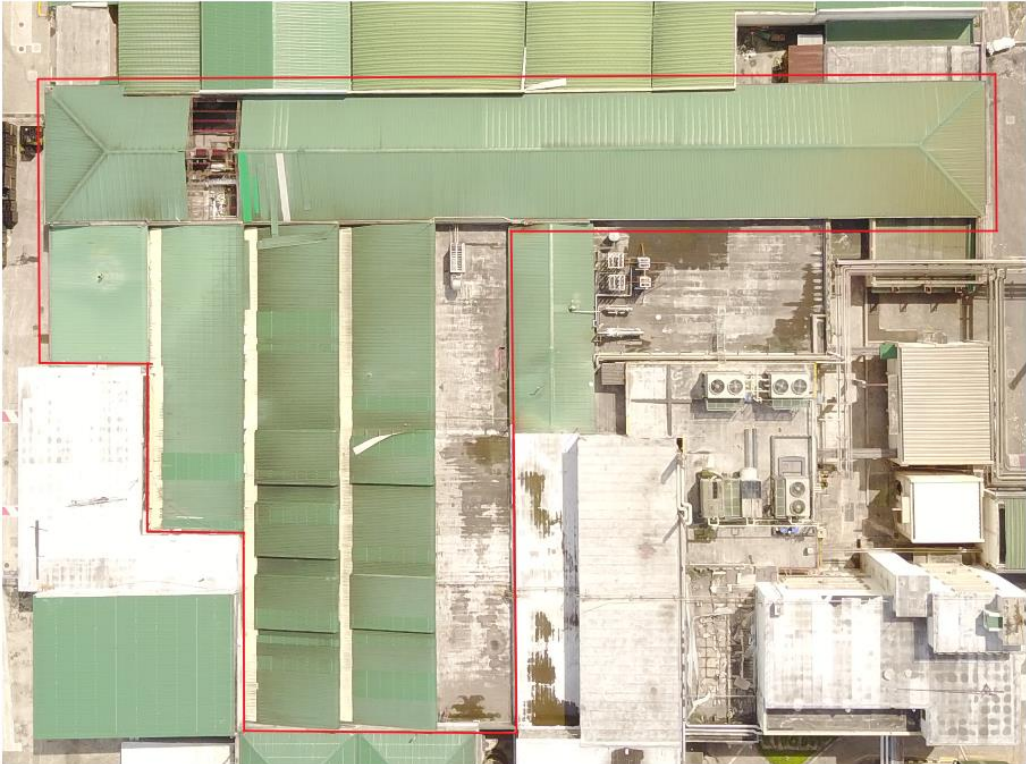
25. Pack Hall: top view

The Pack Hall represented in area number 7 of figure 2, has many problems including corrosion of steel elements, infiltration and the rainwater collection system that is inefficient. Although the roof trusses show signs of corrosion, this is not severe and may be treated, however, the roof sheeting must be replaced.

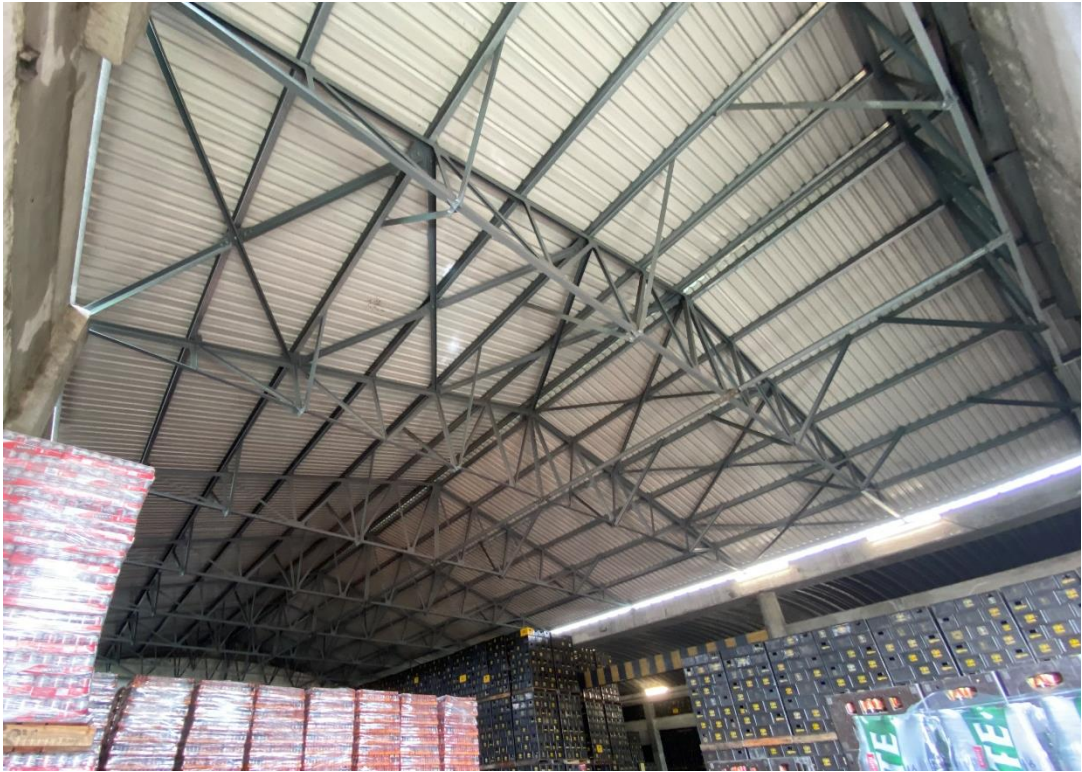
37. Fulls Warehouse: new roof structure

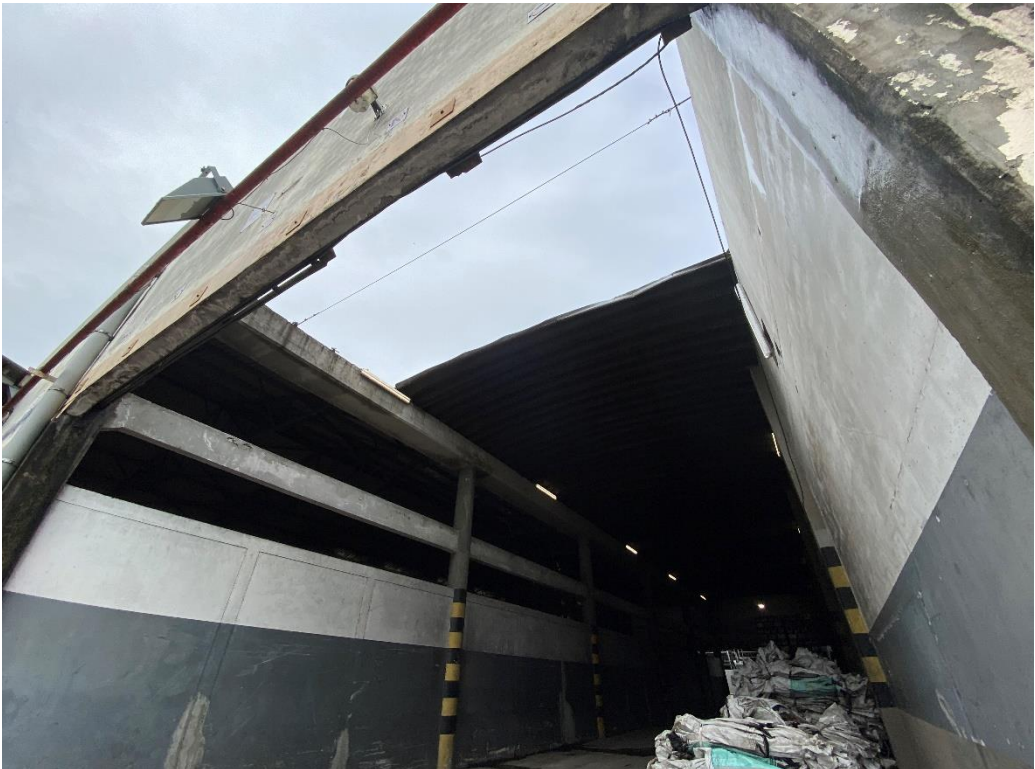
40. Roof between the empty bottles warehouse and the logistics meeting room

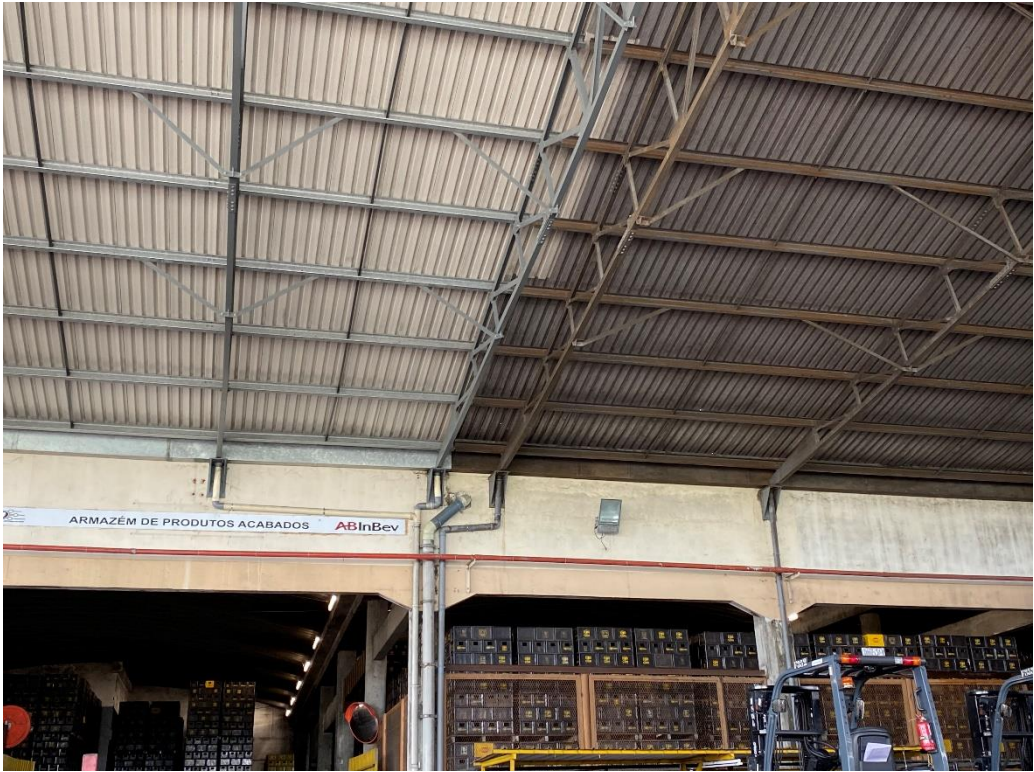
43. Un/Loading Bay: difference between the new and old roof

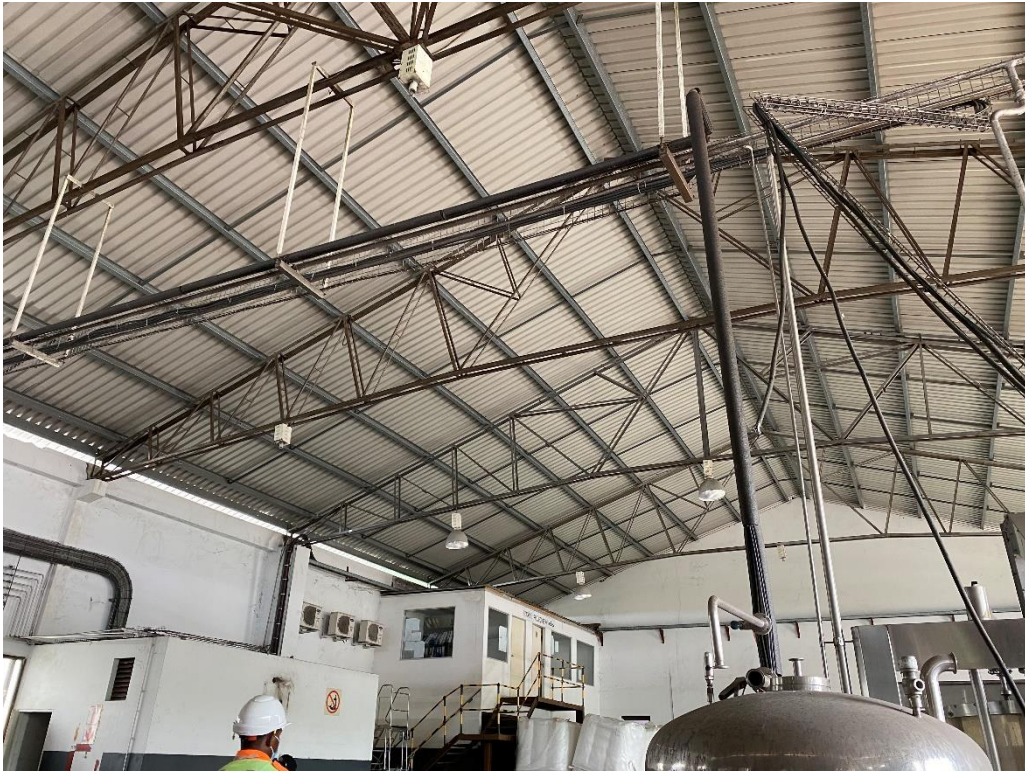
47. Old Chibuko House: roof structure in fairly good condition
